Demonstration Pilot Project to Examine Whether Diffusers Will  
Improve the Ecological Condition of Dead-End Tidal Canals,  
Status Report, November 2014

## Description of the Diffuser Pilot Demonstration Project

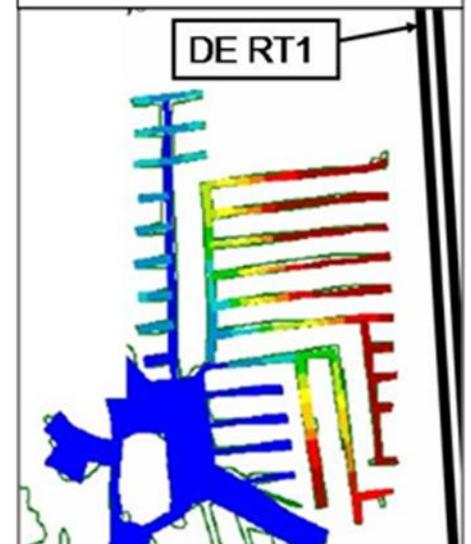
Figure 2. Residence Times in Canals

The canals perform the function of stormwater management ponds. Some have argued that since the canals are tidal that they in fact do not act as ponds. However this is not substantiated. The South Bethany Canals Flushing Study – Entrix 2005 – demonstrates that there is essentially no flushing in the ends of the canals (Figure 2, Residence Time in Canals). Residence Time is defined as the time it takes a concentration to reduce by 36.79%. The computer flushing model was run to simulate three months of tidal action. The areas in red did not reach the 36.79% reduction in the three months. The areas in green reached the 36.79% reduction in one month. The areas in dark blue reached 36.79% reduction in about one day. The resulting finding is that the canals shown in red do indeed act as storm water management ponds since they have no significant exchange of water due to tidal action.

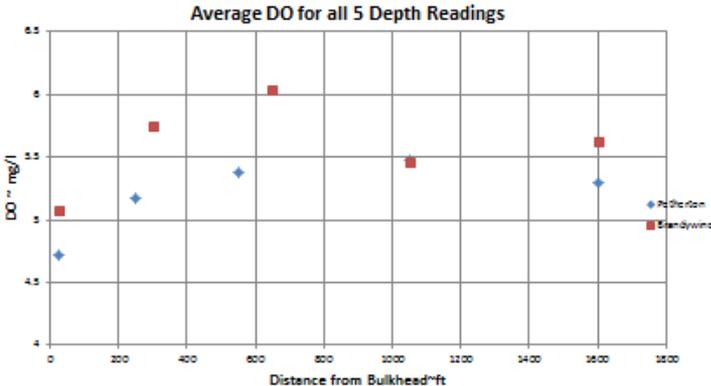
Simple Average DO for all 5 depth Readings Show Diffusers Do Not Increase DO Above Control Canal
