FINAL

South Bethany Canals Sediment Evaluation

August 15, 2019

Woods Hole Group
A CLS Company
107 Waterhouse Road
Bourne, MA 02532 USA
(508) 540-8080

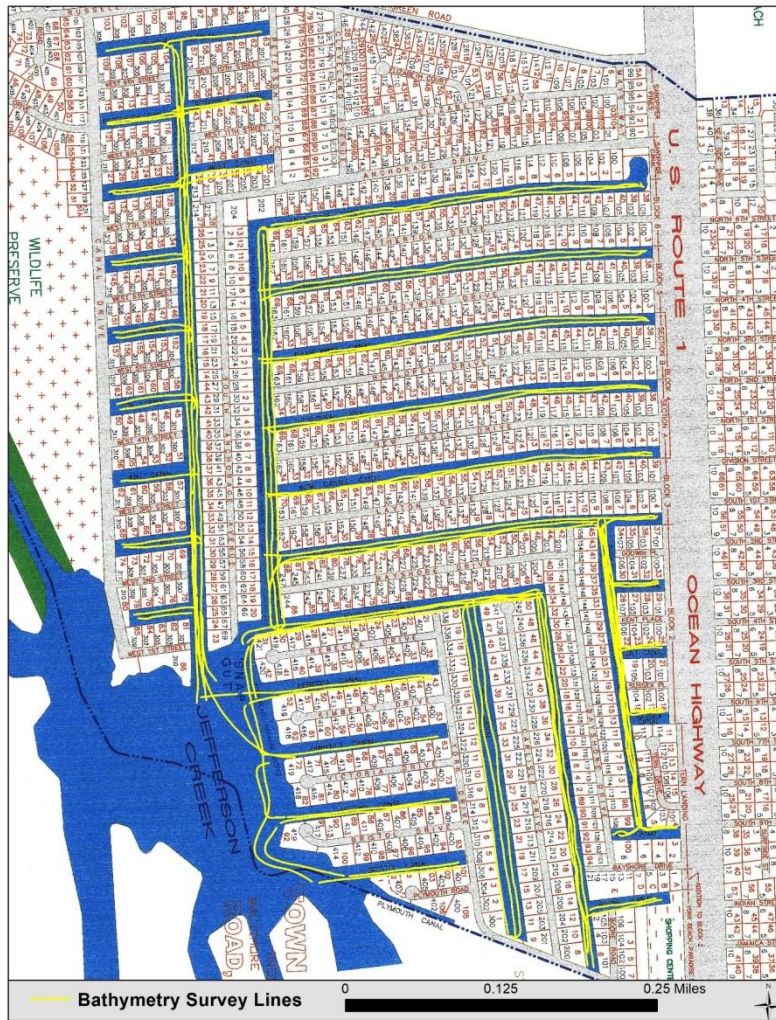
Figure 1. Bathymetry survey tracklines collected September 20, 2018.

A total of 13.8 miles of survey lines were collected over the course of the bathymetric survey (Figure 1). A minimum of two along-channel lines were collected in each canal, with a third line along either the center of the canal or zig-zagging across the previously collected channel lines to optimize the coverage of the survey. Soundings were recorded in feet relative to NAVD88, resulting from the real-time RTK tide processing. Following the survey, data were post-processed to remove erroneous soundings (for example, when turbulence from the boat wake prevented the transducer from sensing the bed), smooth the 1-Hz data through averaging and interpolating a full-channel bathymetry map (Figure 2).

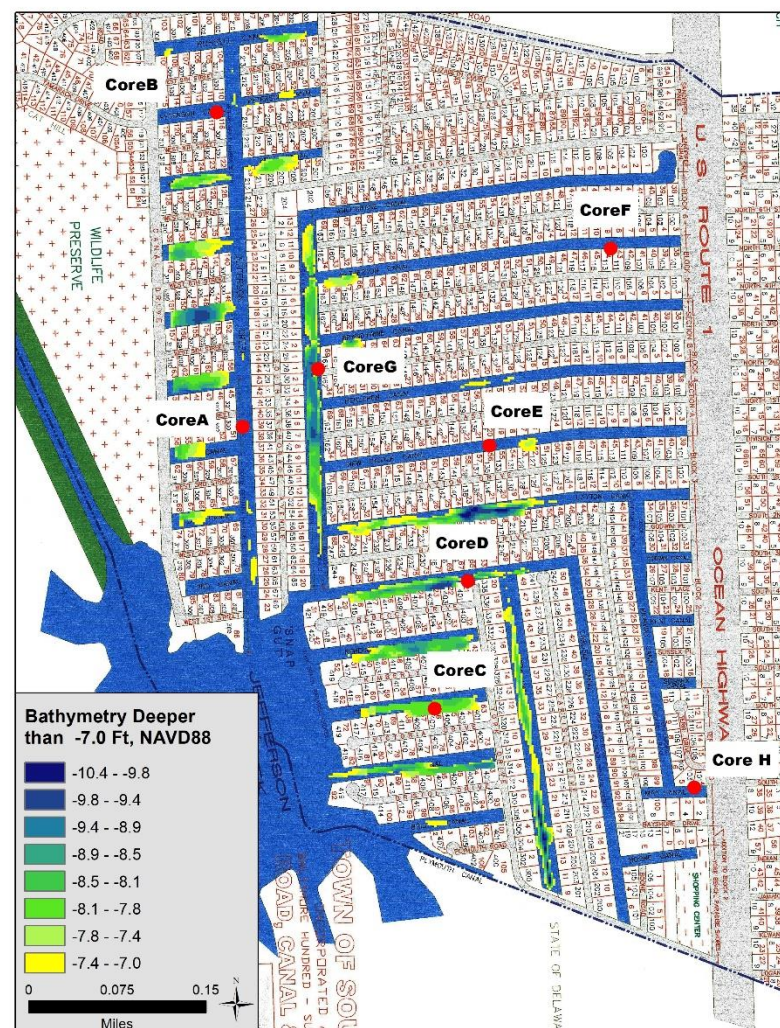
Figure 4. Bathymetric regions with elevation of -7.0 feet NAVD 88 or lower, collected September 20, 2018.

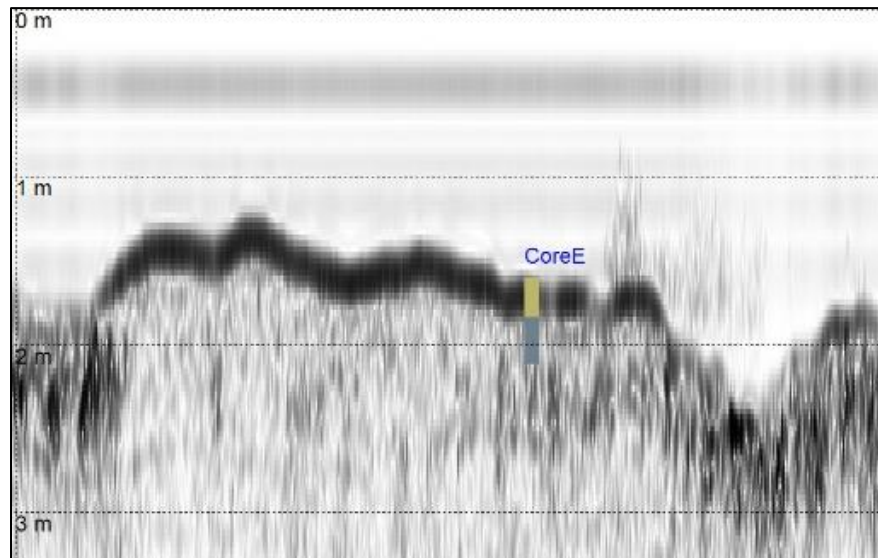
Figure 9. Correlation between acoustic sub-bottom imagery and sediment core E, collected in New Castle canal.

The sediment core structure correlated well with the sub-bottom acoustic survey results, providing confidence in the interpretation of the acoustic data. For example, in Figure 9, the thickness of the dark acoustic return at the sediment-water interface matches the thickness of medium grained sand layer at top of Core E, which overlays estuarine clay in New Castle Canal.

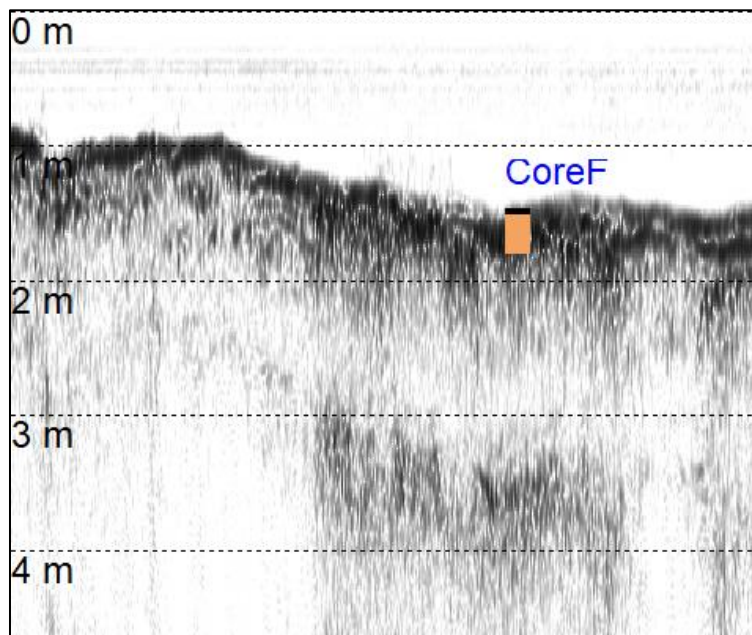
Figure 10. Correlation between acoustic sub-bottom imagery and sediment core F, collected in Petherton canal.

In Figure 10, the acoustics from Petherton Canal correlate well with sediment Core F – a thin layer (2 inches) of loosely consolidated organic material overlays medium to fine sand.

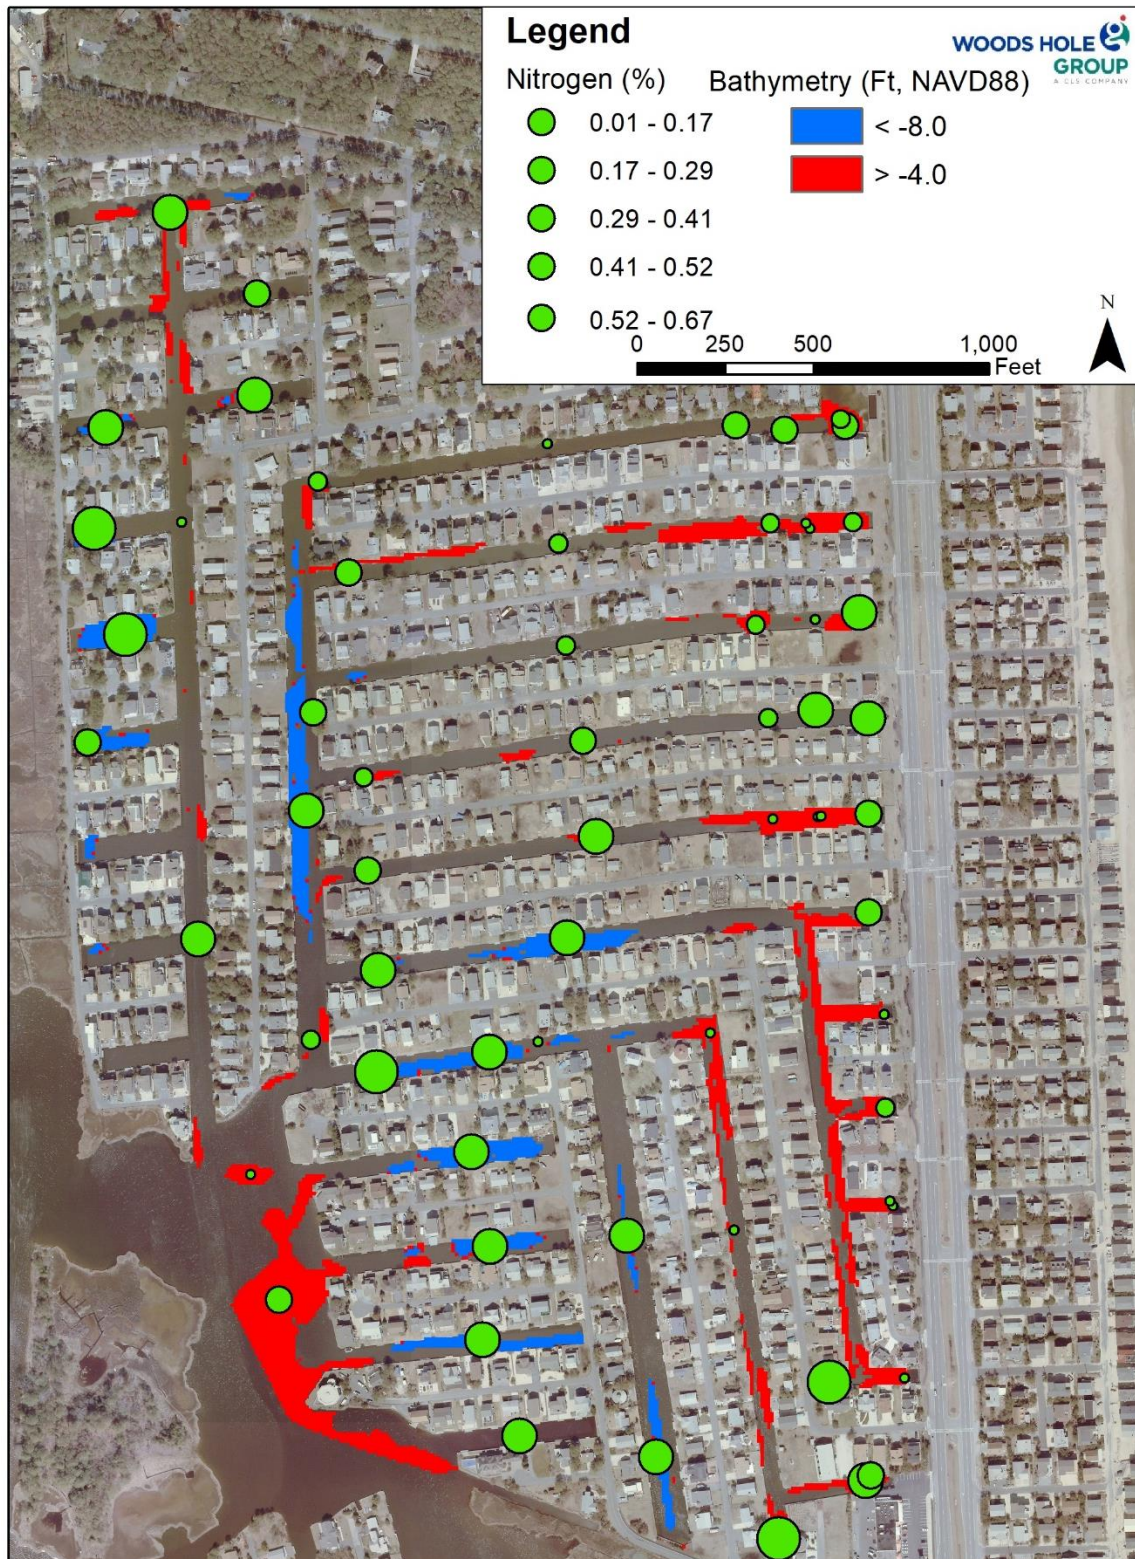
Figure 12. Total nitrogen in surficial grab sediments.

Concentrations of particulate nitrogen range from 0.01 to 0.67% by weight of the sample (Figure 12). These values fall within the typical concentrations observed in estuarine settings (Boynton and Kemp, 1985).

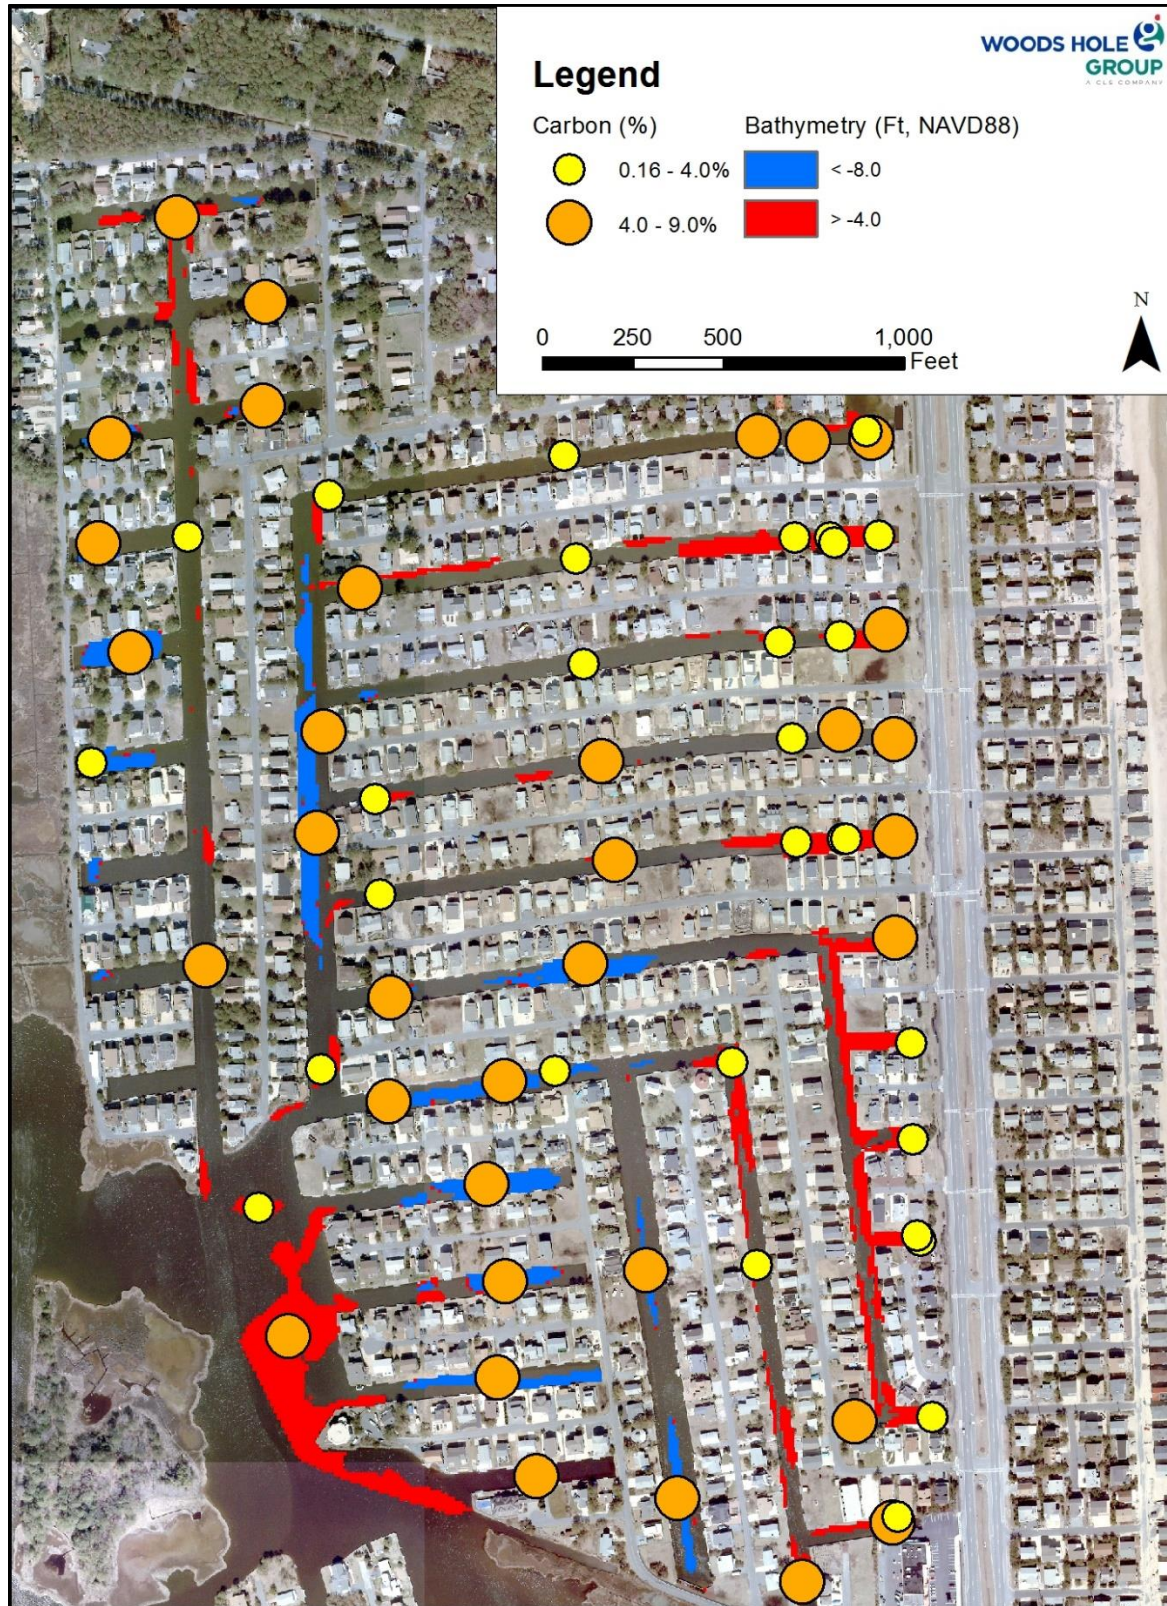
Figure 13. Total carbon in surficial grab sediments. Samples containing greater than 4% carbon (orange circles) are considered 'hot spots' of nutrient regeneration.

The samples had a large range of total carbon, from (0.16% to 9%) by weight of the sample. The data are spatially variable, and can be mostly be explained by grainsize variation between the sites, with the highest concentrations of carbon typically found with fine-grained material at the ends of canals and in deeper canals with depths greater than -8 ft NAVD88. Samples containing higher than 4% PC are highlighted in Figure 13 with the orange circle. A threshold of 4% PC can be an indicator of high nutrient regeneration. Again, the restricted ends and deep sections of the canals typically fall in this 'hotspot' categorization, over half (34) of the samples contained >4% PC, suggesting the entire system is carbon-rich and has the potential for high nutrient regeneration.

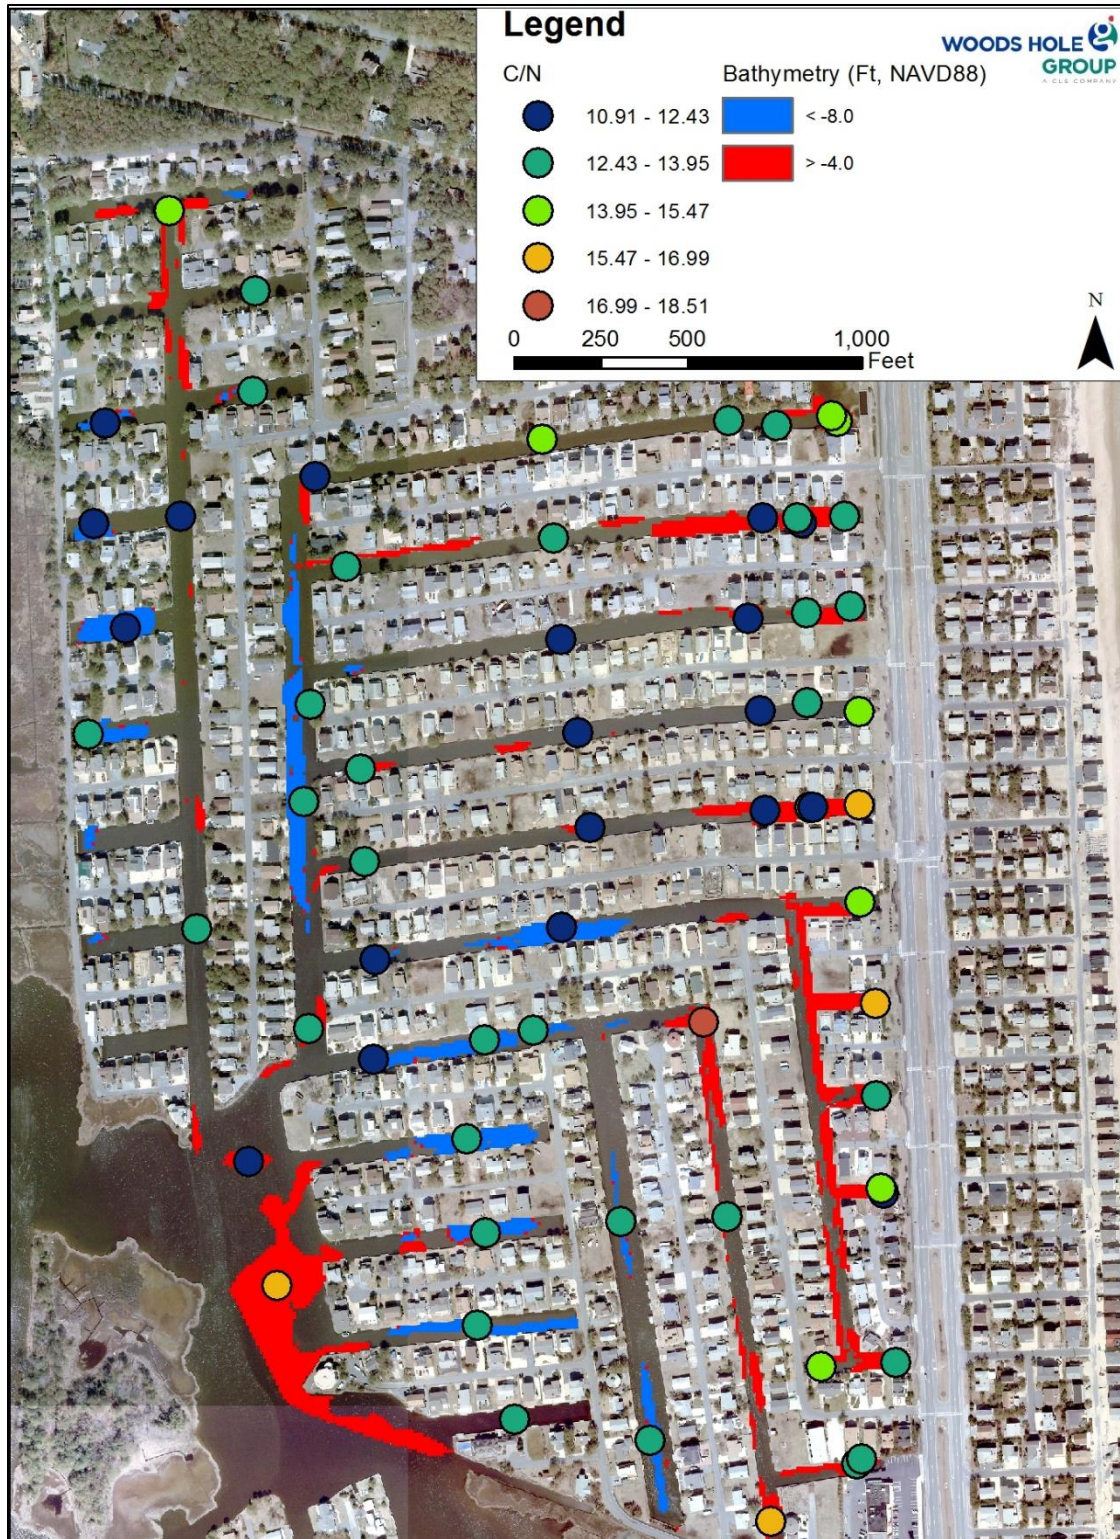
Figure 14. Carbon to Nitrogen (C:N) ratio in surficial sediment grab samples. All samples have ratios higher than 6.6, a typical marine value.

The ratio of carbon to nitrogen (C: N) in coastal and estuarine sediments provides a reasonable estimate of the organic matter source. The C:N of algae has a nominal C:N ratio of 6.6 while terrestrial plants tend to have a much higher C:N value of >20:1 (Lamb et al., 2006). Figure 14 shows the spatial distribution of C:N. All samples ranged from ratios of 10.9 to 18.5, with an average C:N ratio of 13.1 ± 1.4 , which indicates a mainly terrestrial source for the sedimentary organic matter. The source material for the organic matter could be derived from grass clippings or wetland plants such as *Spartina alterniflora*. However, the sediment C:N ratio can only suggest a possible carbon source as the sediment carbon is likely degraded and often results from a mixture of carbon sources being deposited to the sediment surface.
