Coastal Hazard Analysis

Project Narrative: South Bethany, DE

February 2021

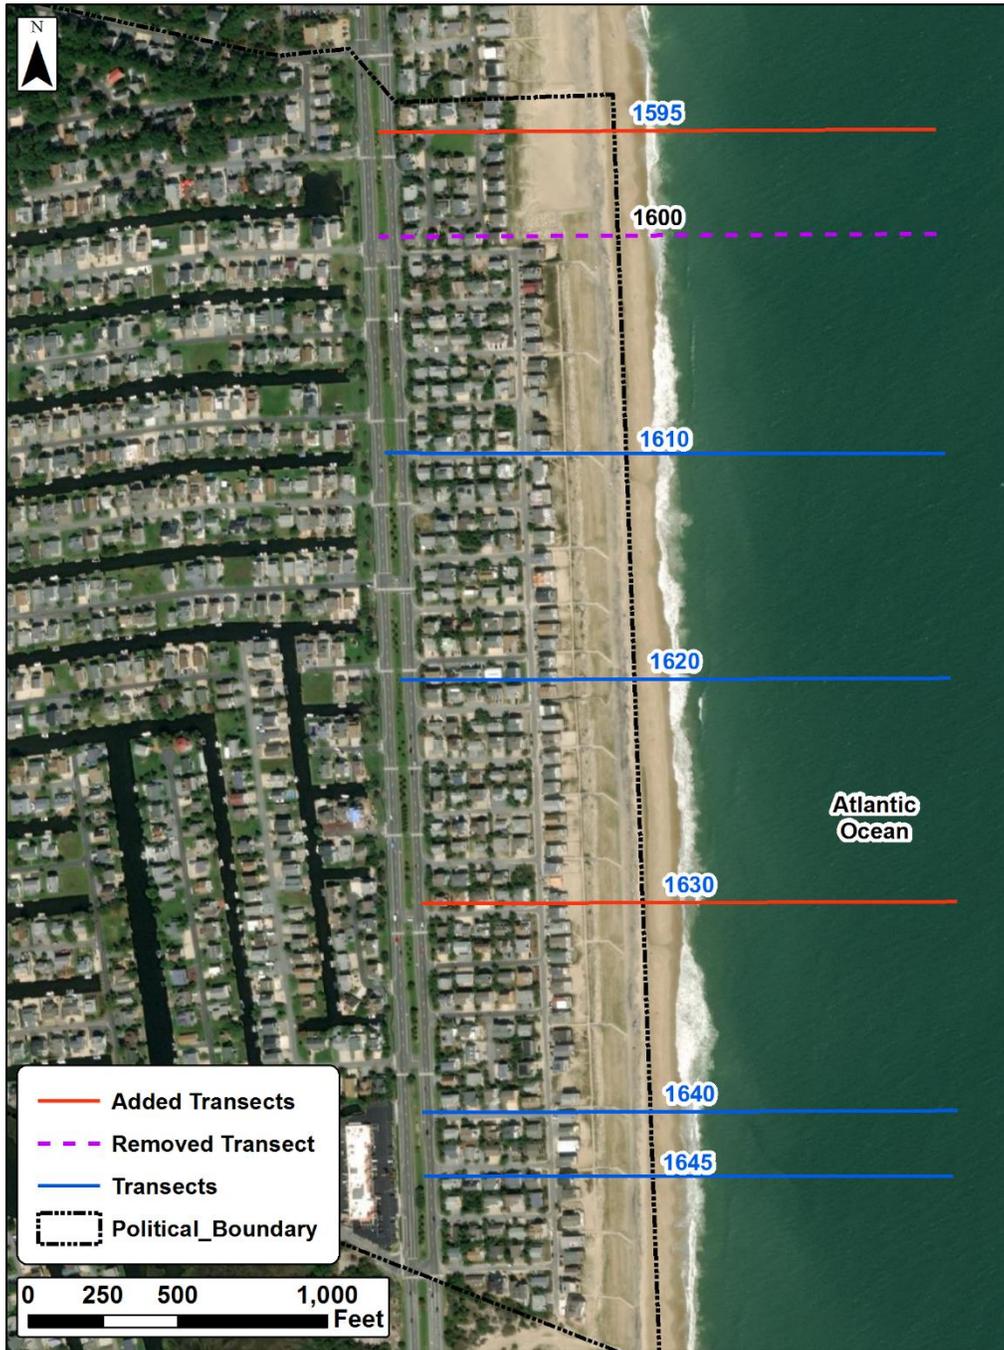
Figure 1. South Bethany transect layout

The transect layout at South Bethany was based on the effective Sussex County FIS completed by Risk Assessment, Mapping and Planning Partners (RAMPP) in October 2014 (FEMA 2018c). The transect layout for this study is shown in Figure 1. Transects with IDs 1610, 1620, 1640, and 1645 were incorporated from the study. Transect 1595 was added at the north border of South Bethany to represent areas north of Ocean Drive. Transect 1630 was added to reduce spacing between transect 1620 and 1640. Transect 1600, previously modeled in the RAMPP study, was removed because it was not regionally representative of the dune feature to the north or south. As shown in Figure 2, the large dune feature at Transect 1600 was not a longshore consistent representation of the area.

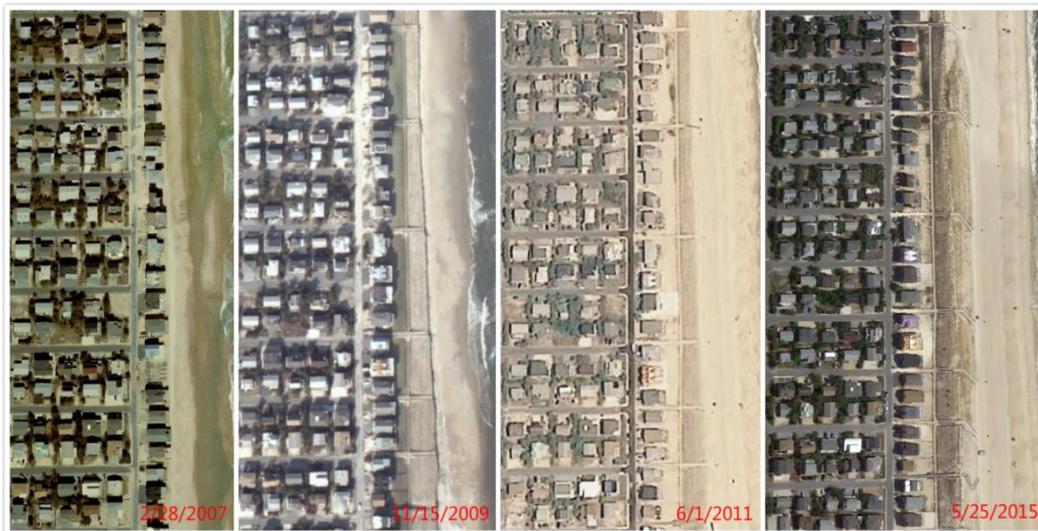
Figure 5. Aerial imagery of South Bethany Beach before and after nourishment

According to our review of the aerial imagery at South Bethany, the nourished footprint of the beach has been in place for nearly 13 years. Figure 5 shows the aerial images in the north of South Bethany Beach before the nourishment events in 2007, and after nourishment activities since 2008. Figure 6 shows the aerial imagery of the same area taken in 2017.

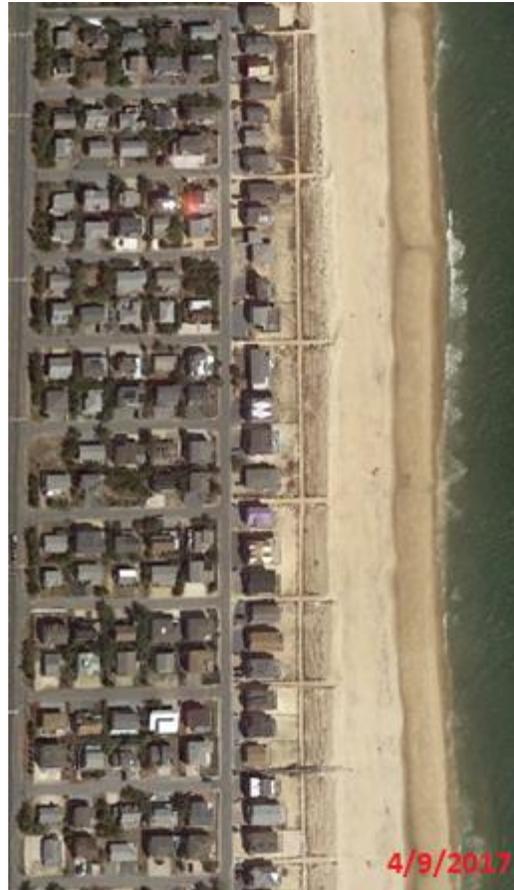
Figure 6. Aerial imagery of South Bethany Beach on 4/9/2017

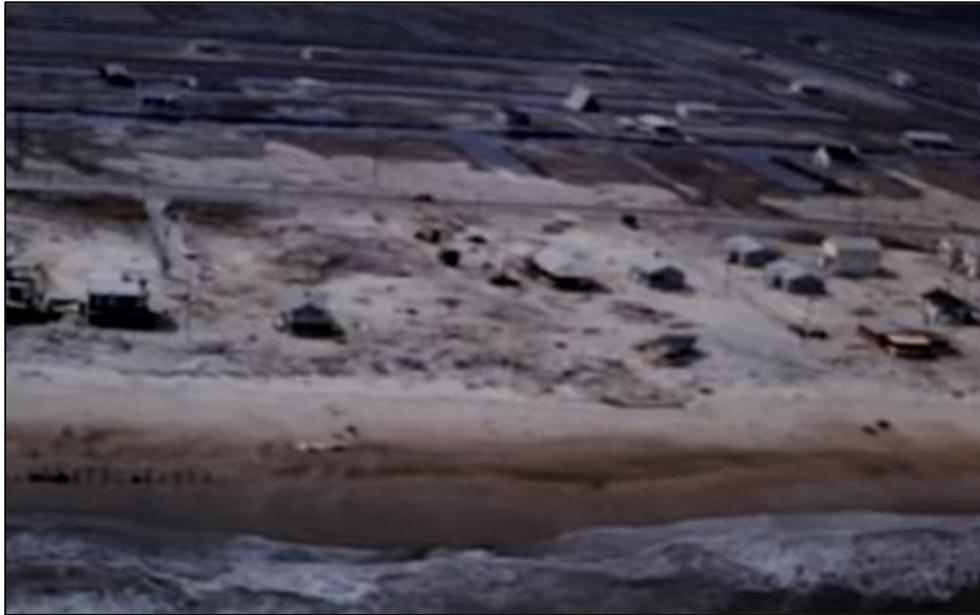
Figure 8. Still image of flyover video footage taken of South Bethany after the Ash Wednesday Storm (Delaware Public Archives, 1962)

Erosion from several tropical cyclones and winter storms has been documented at South Bethany. The most severe case of storm damage occurred from the Ash Wednesday Storm in 1962, during which most structures in South Bethany were destroyed. Figure 8 and Figure 9 show images of South Bethany documented from archived aerial video footage and photos captured after the storm.

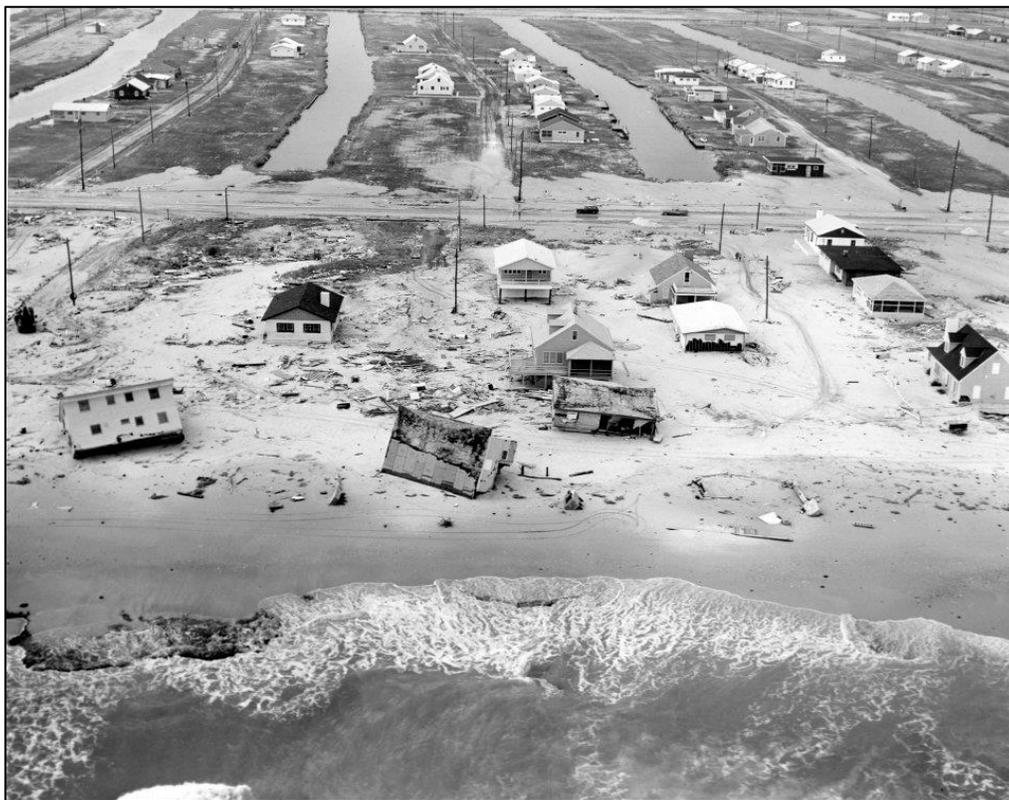
Figure 9. Image of post-storm damage to South Bethany (Delaware Public Archives, 1962)

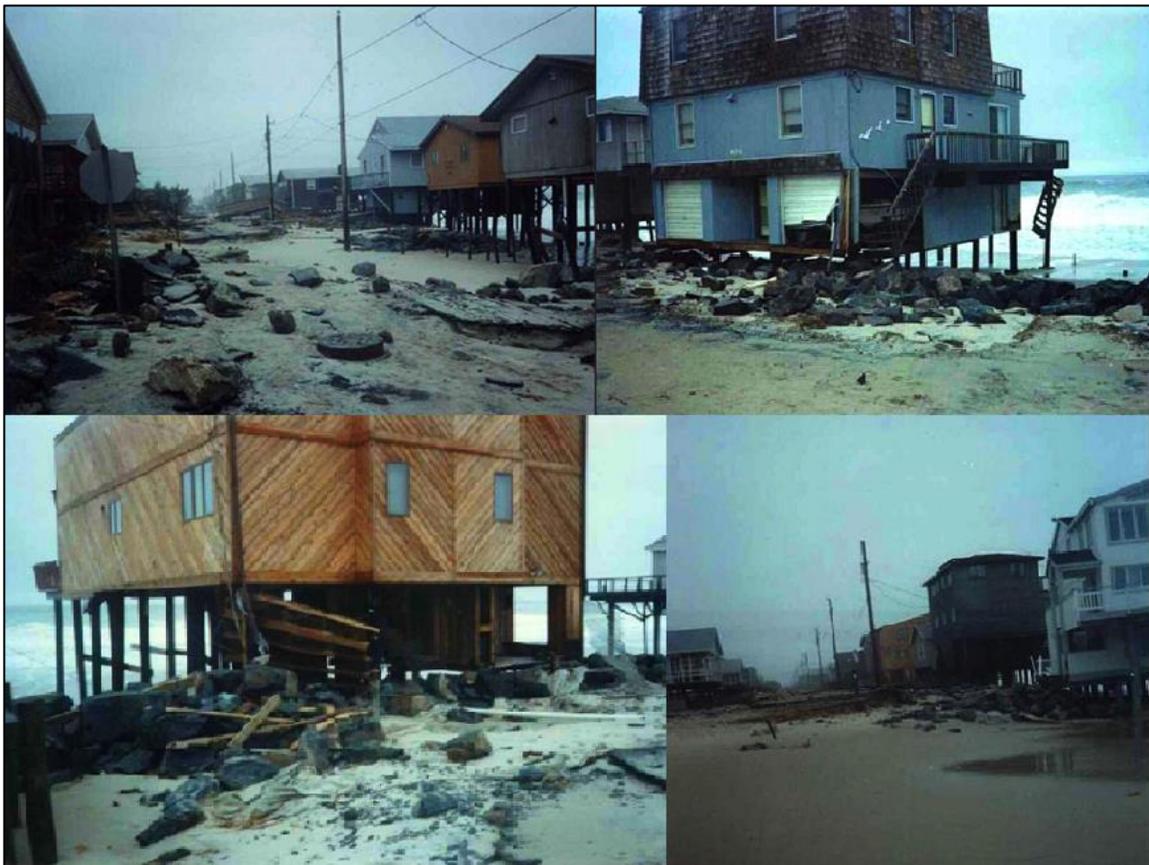
Figure 10. 1994 post-storm photos, South Bethany (Cannon, 1994)

In the 1990s, winter storms impacted South Bethany and caused overwash and damage to Ocean Drive. Storm damage from a January 1992 event was noted in a Delaware Geological Survey Report: “Washovers were common in South Bethany. Scarping and erosion of the road behind the first row of houses was common. Sewer lines and well heads were exposed and damage to wells was common” (Ramsey and Tally, 1992). Images from a 1994 winter storm in Figure 10 show damage to oceanfront homes, overwash and damage to Ocean Drive, and an exposed revetment fronting the roadway. The damage resulting from these storms resulted in relatively small-scale emergency nourishments in 1992, 1994, and 1998. Flooding in South Bethany was also documented due to the effects of Hurricane Isabel in 2003.

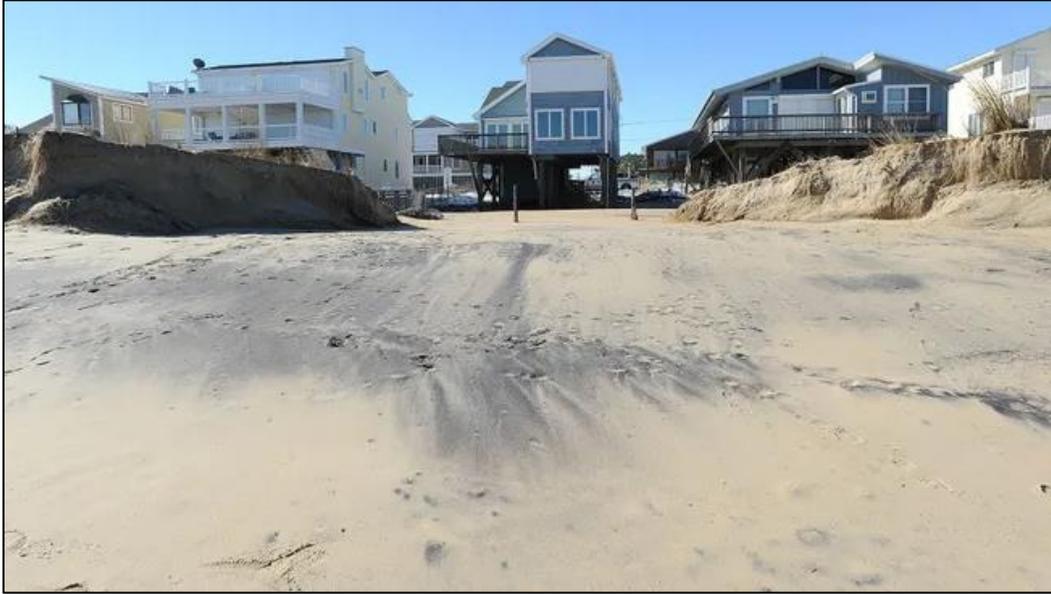
Figure 11. 2016 post-storm dune erosion at South Bethany (Murray, 2016)

After completion of the 2008 Bethany Beach/South Bethany Coastal Storm Damage Reduction Project, significant dune and berm features were constructed along the shoreline. More recent storms have had an erosion impact on the nourished features at South Bethany, including Nor’Ida (2009), Hurricane Sandy (2012), and most recently a winter storm in January 2016. Post-nourishment erosion from these storms was characterized by shoreline retreat and dune scarping. In one small area near the southern portion of South Bethany, the dune was breached during the 2016 storm, causing overwash and flooding of the swale between the nourished dune and the oceanfront

homes, as shown in Figure 11 and Figure 12. Survey-based documentation of the storm-induced erosion impacts from the post-nourishment storms is detailed in Section 4.1.3.

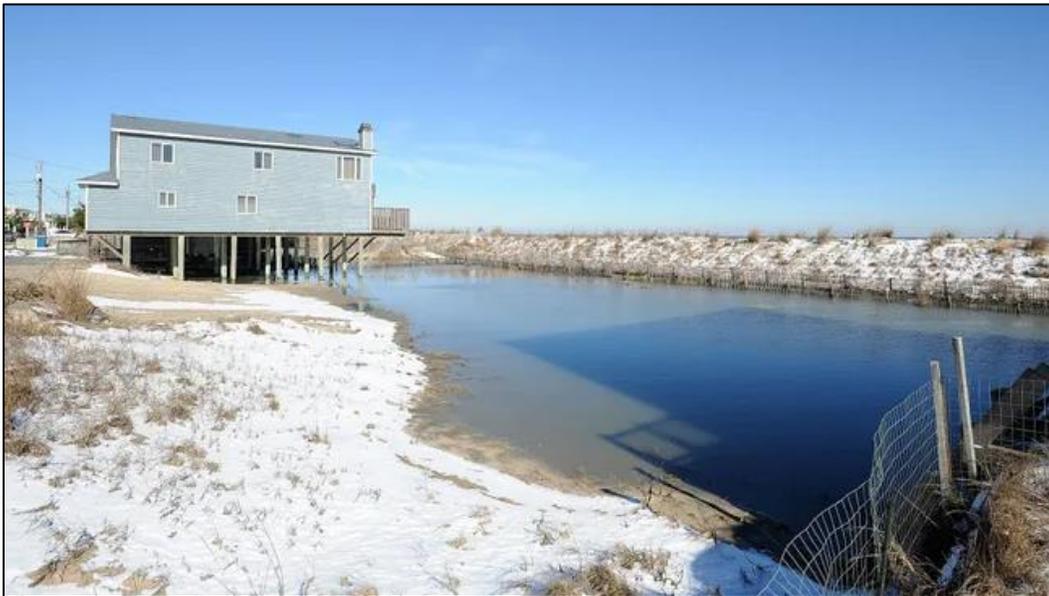
Figure 12. 2016 post-storm flooding at South Bethany (Murray, 2016)

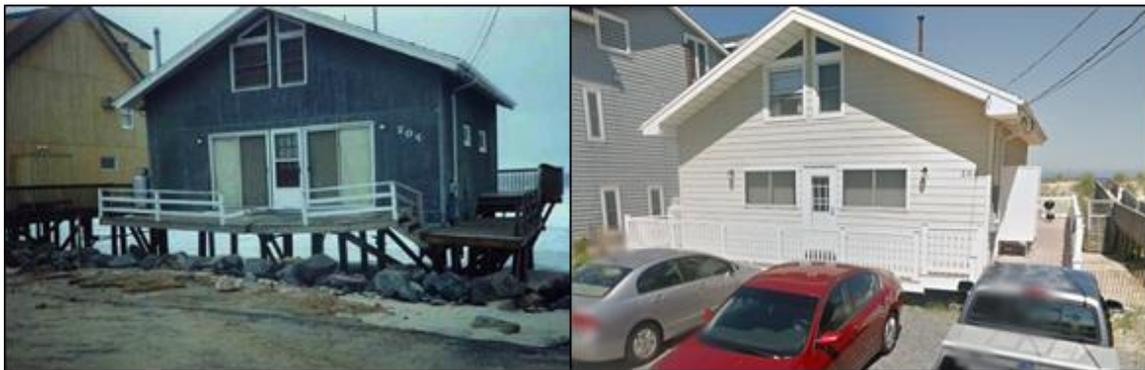
Figure 13. Conditions of oceanfront home in South Bethany in the 1990s (left - Cannon, 1994) compared to more current Google Street View captured in July 2014 (right)

Review of historical imagery, survey data, and LiDAR and discussion with local officials has documented a number of changes to the site conditions at South Bethany since many of the historic storms impacted the area prior to 2008, including the Bethany Beach/South Bethany Coastal Storm Damage Reduction Project that provided a vegetated dune system and moved the shoreline farther seaward of oceanfront parcels. Discussion with DNREC provided details on a buried rock revetment that was constructed along the seaward edge of Ocean Drive. Figure 13 shows an example of an oceanfront home on Ocean Drive in 1994, compared to more a recent Google Street View image of the same location. The image comparison shows an older exposed revetment at the edge of Ocean Drive. The newer image shows a higher road elevation relative to the home, with gravel parking at the location of the previous revetment.

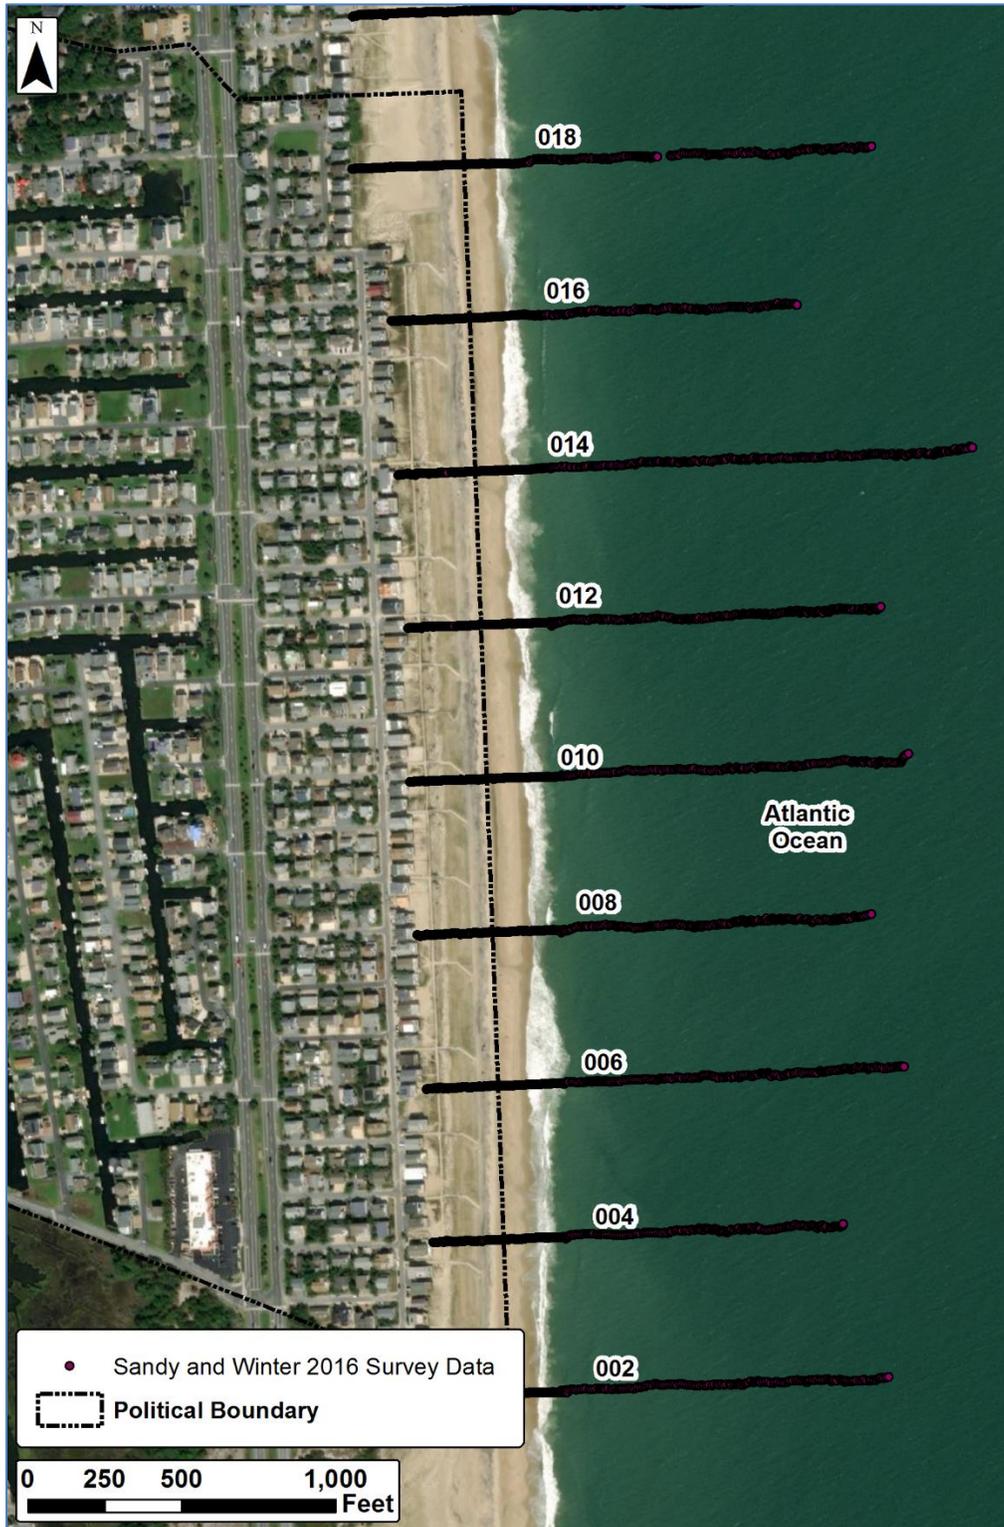
Figure 17. Hurricane Sandy and 2016 Winter Storm survey transect locations

Due to the profile conditions that exist at this site following the 2008 Bethany Beach/South Bethany Coastal Storm Damage Reduction Project, Compass conducted an evaluation of shoreline and volume change of the following three storms: 2009 Nor'Ida, 2012 Hurricane Sandy, and the 2016 Winter Storm. Compass obtained pre-storm and post-storm survey data for each of these storms and evaluated the post-nourishment erosion response for each. Each storm was evaluated relative to the peak observed water levels near the site, which are shown in Table 3, similar to the original dune erosion volume analysis conducted to develop FEMA's dune erosion guidelines (Hallermeier and Rhodes, 1988). Figure 15 and Figure 16 show the survey data locations and a sample of pre- and post-storm survey profiles for Nor'Ida. Figure 17 shows Hurricane Sandy and 2016 Winter Storm survey data locations, Figure 18 shows Hurricane Sandy pre- and post-storm profiles, and Figure 19 shows 2016 Winter Storm pre- and post-storm profiles. As shown in Figure 15, odd-numbered survey profile stations were available for pre- and post-storm Nor'Ida, whereas in Figure 17, even-numbered survey profile stations were available for both Hurricane Sandy and the 2016 Winter Storm.

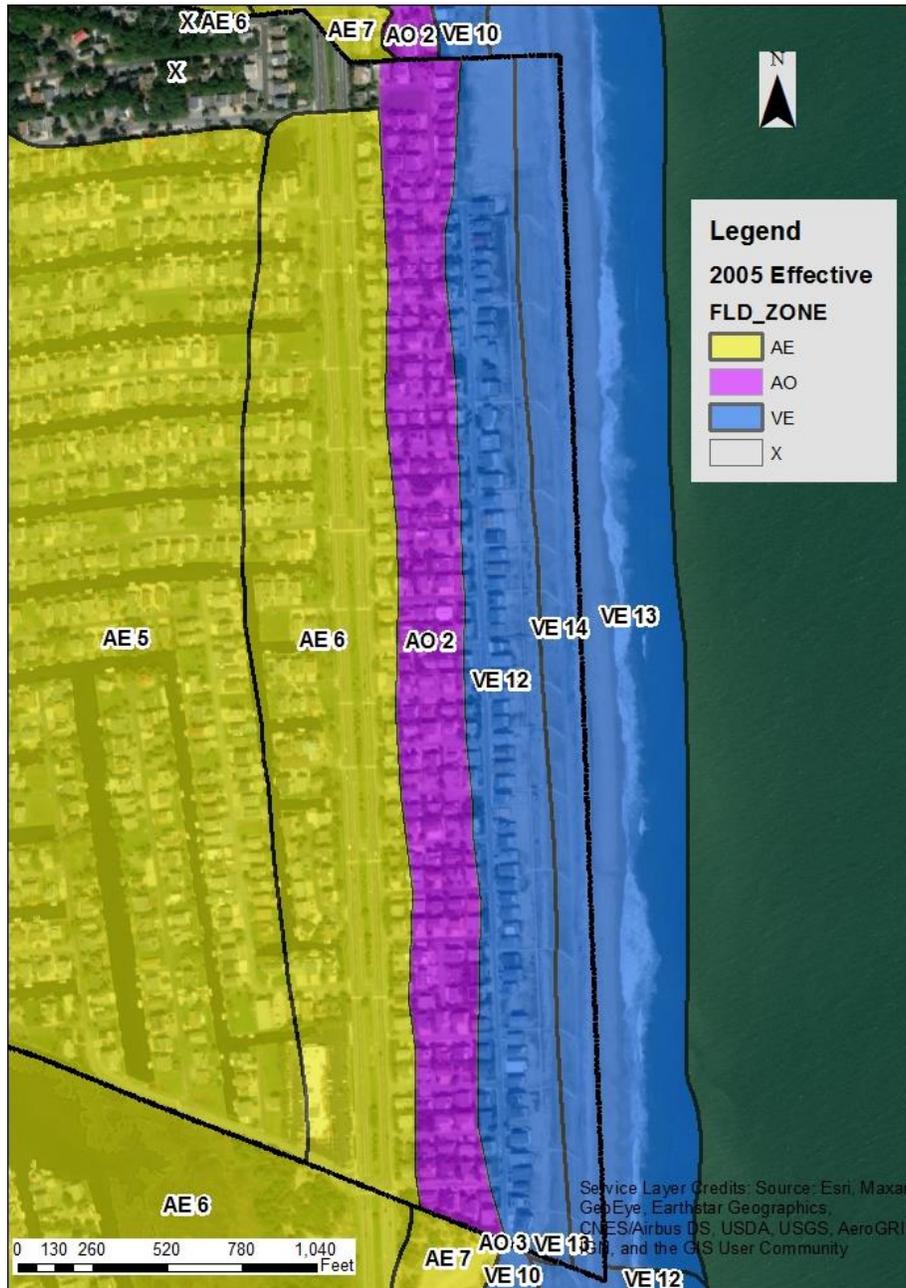
Figure 28A. Effective mapping for Town of South Bethany (2005) and surrounding areas (2015)

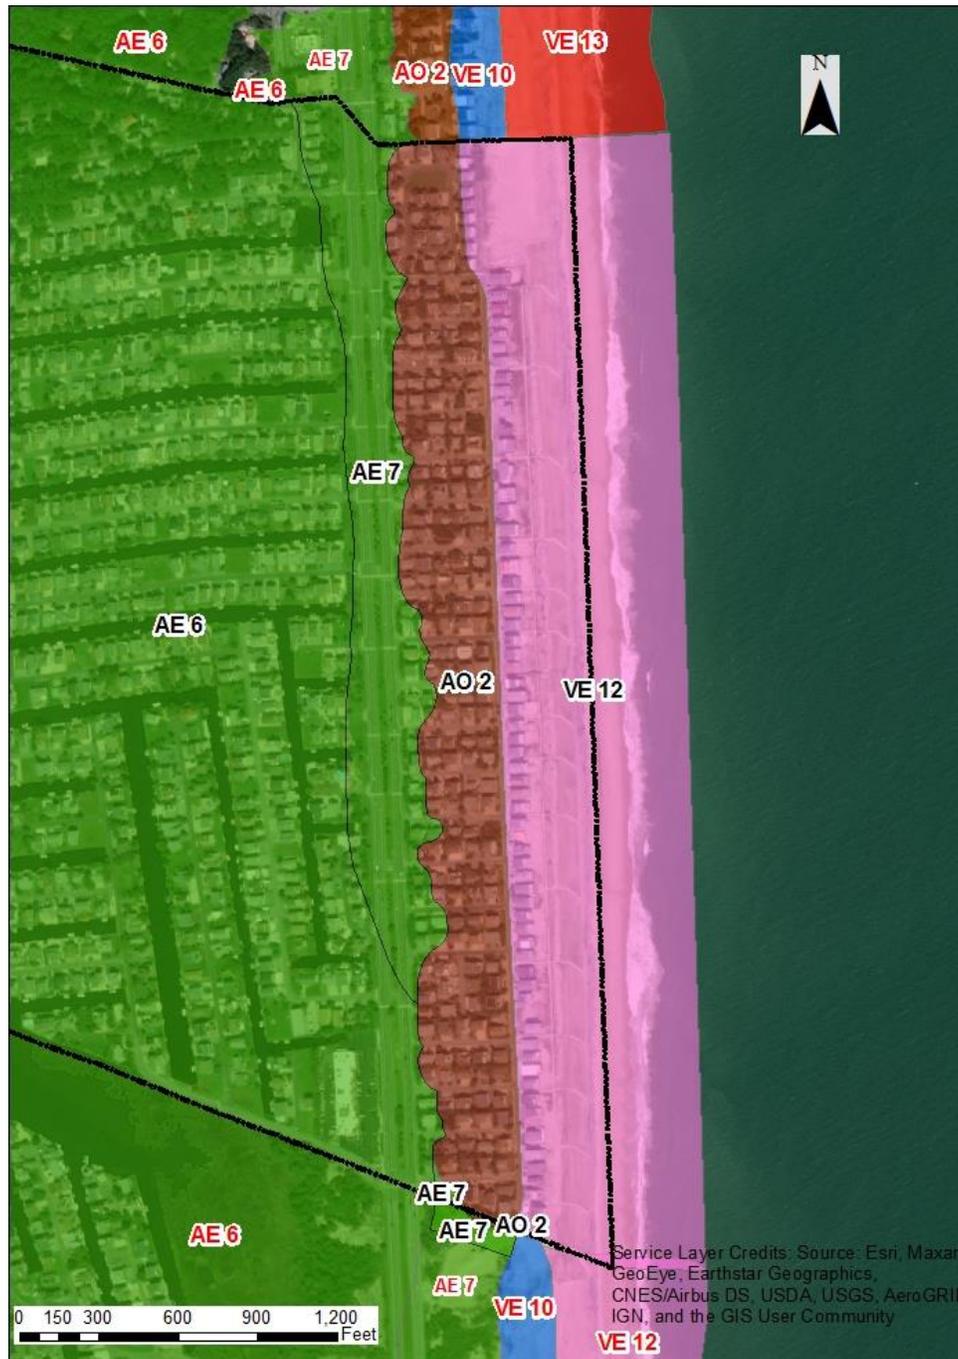
Figure 29A. Proposed mapping within Town of South Bethany (zones labeled in black) with effective mapping of surrounding areas (zones labeled in red)

A summary of the proposed LOMR mapping results at each transect is listed in Table 8. Note that the value ‘Zone VE Limit’ explains the dominating characteristic (e.g., PFD, runup, or wave height) that determined the mapping location of the first Zone VE. Additionally, the ‘SFHA Boundary’ describes the dominating characteristic (e.g., overtopping, wave height, or SWEL) that determined the most seaward extent of the Special Flood Hazard Area (SFHA), which includes all zones associated with land areas covered by the floodwaters of the base flood.
