WETLANDS AND OTHER WATERS OF THE U.S.  
DELINEATION REPORT

YORK ROAD FLOOD MITIGATION PROJECT

TOWN OF SOUTH BETHANY  
SUSSEX COUNTY, DELAWARE

July 2024

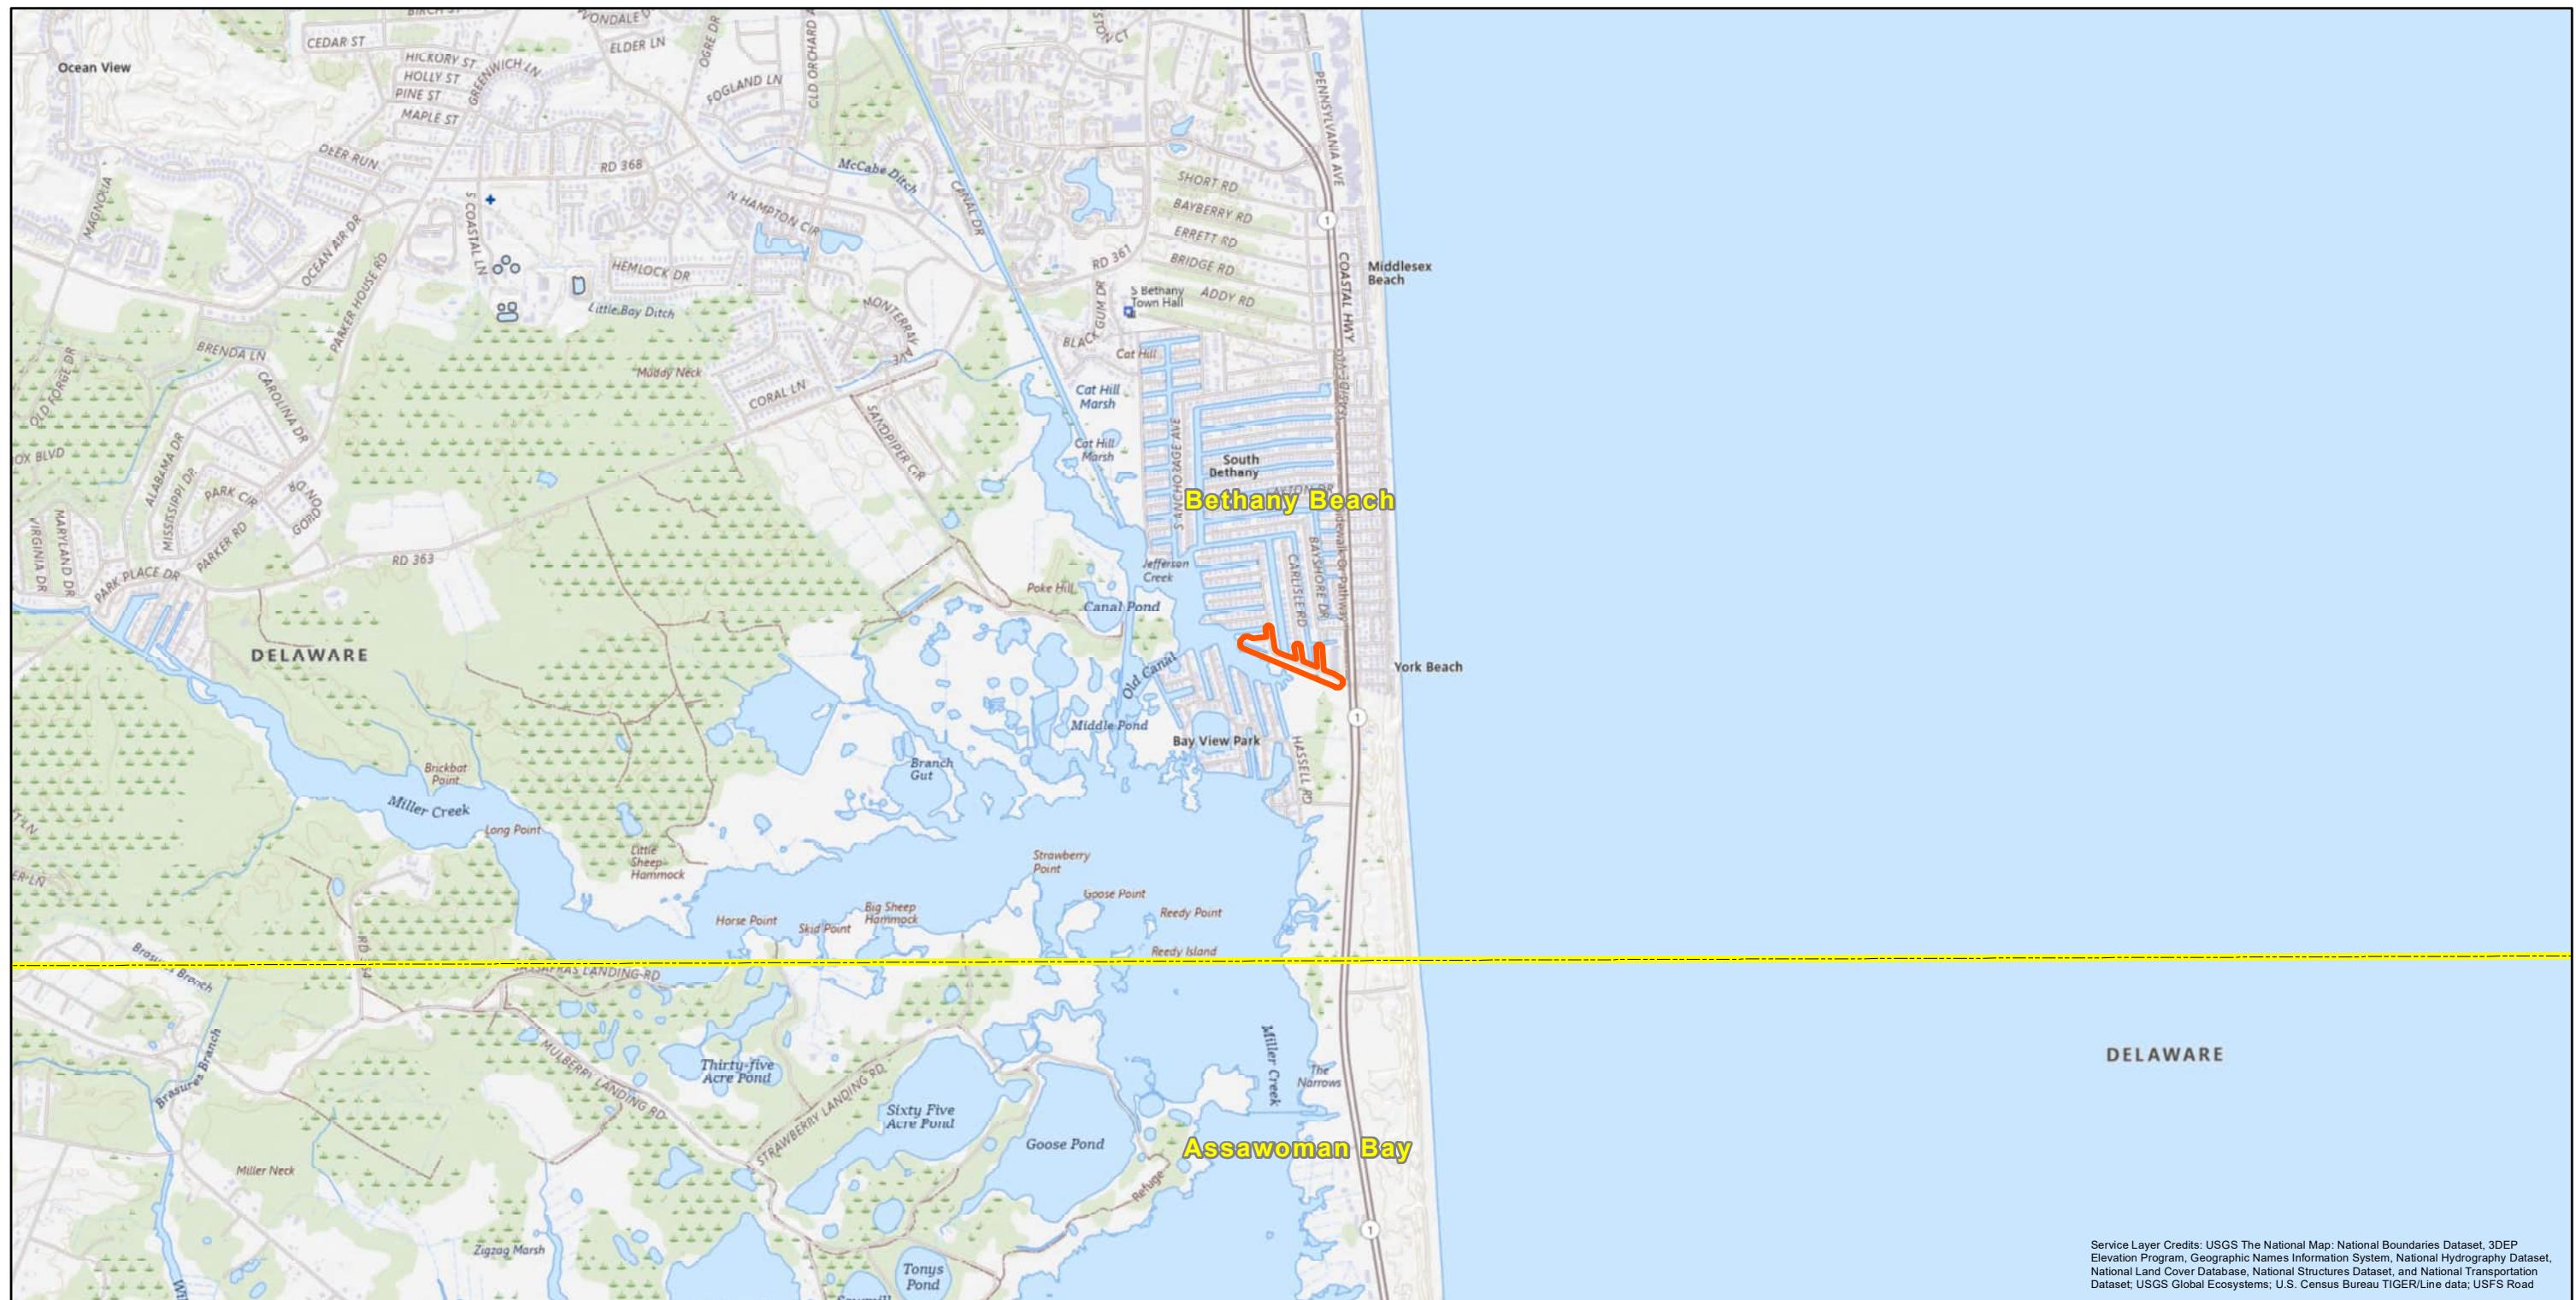
**AECOM**  
**Figure 1**  
**Project Location**  
**York Road Flood Mitigation Project**  
Town of South Bethany  
Sussex County, Delaware

The York Road Flood Mitigation Project is located in the Town of South Bethany, DE in a residential community bordered by Fenwick Island State Park on the south end (Site). The Site has a history of flooding, which has necessitated a study of potential mitigation actions. The existing roads are at a low elevation and are surrounded by open tidal waters, as well as tidal marsh areas. The Project Study Area (PSA) is approximately 5.76 acres and was determined based on an approximate buffer of 40 feet around the roads expected to be impacted by project activities, as well as a greater area to the south of York Road to capture the tidal marsh (Figure 1).

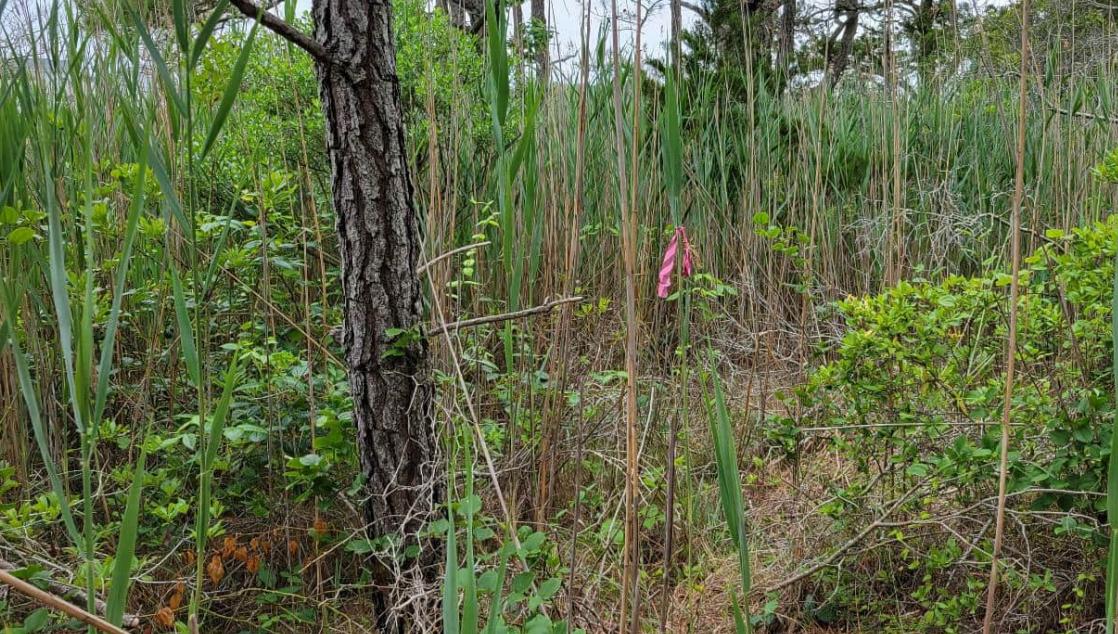
<b>Client Name:</b> Town of South Bethany, DE		<b>Site Location:</b> York Road Flood Mitigation Project Sussex County, Delaware	<b>Project No.</b> 60707136
<b>Photo No.</b> 1	<b>Date:</b> 6/5/2024

Wetland data point taken to represent the PFO community type within the Wetland 1 complex. Tidal influence is less impactful at this upper range, which may be allowing for more persistent vegetation (trees and shrubs) to grow.

<b>Direction Photo Taken:</b> West			
<b>Description:</b>  View of Wetland 1 (W1 PFO) at the palustrine forested community. The dominant tree species in this community was loblolly pine ( <i>Pinus taeda</i> ).

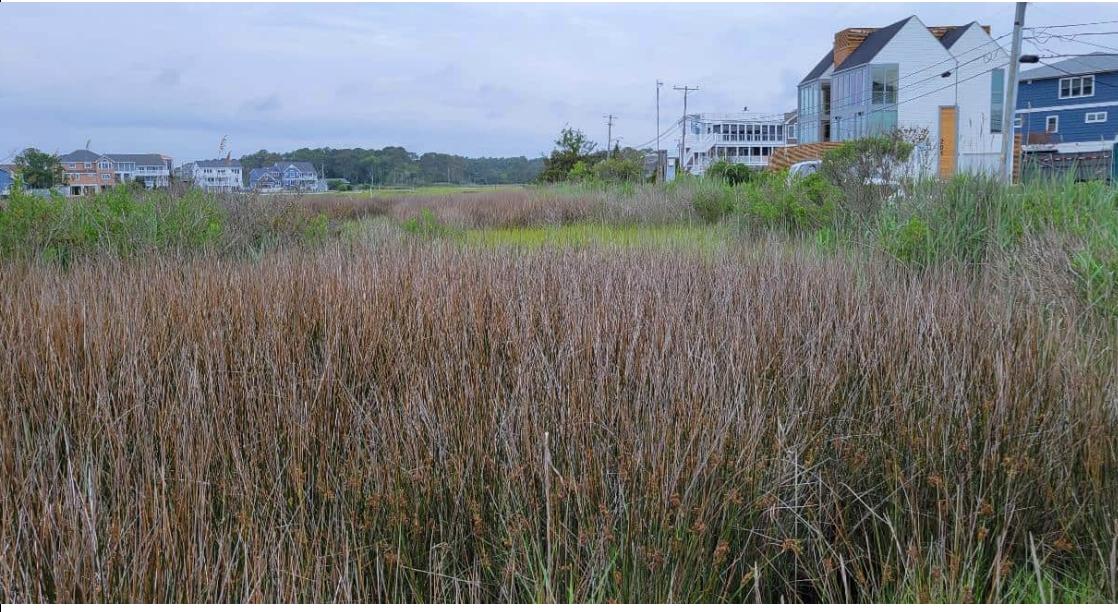
<b>Photo No.</b> 2	<b>Date:</b> 6/5/2024	
<b>Direction Photo Taken:</b> West		
<b>Description:</b>  View of Wetland 1 (W1 EEM) at the estuarine emergent community. Soft rush ( <i>Juncus effusus</i> ) and salt-grass ( <i>Distichlis spicata</i> ) are the dominant emergent species, with scattered groundsel ( <i>Baccharis halimifolia</i> ) shrubs.

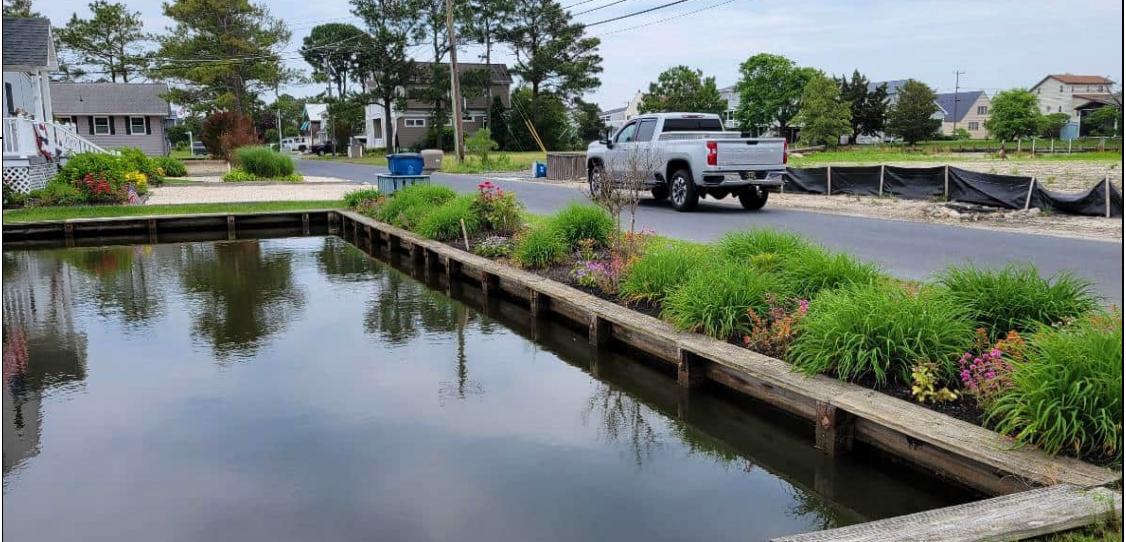
<b>Photo No.</b> 4	<b>Date:</b> 6/5/2024	
<b>Direction Photo Taken:</b> East

<b>Description:</b>  View of Wetland 3 (W3 EUB), an estuarine unconsolidated bottom feature. This is a reinforced canal used for recreational boating and is named York Canal.

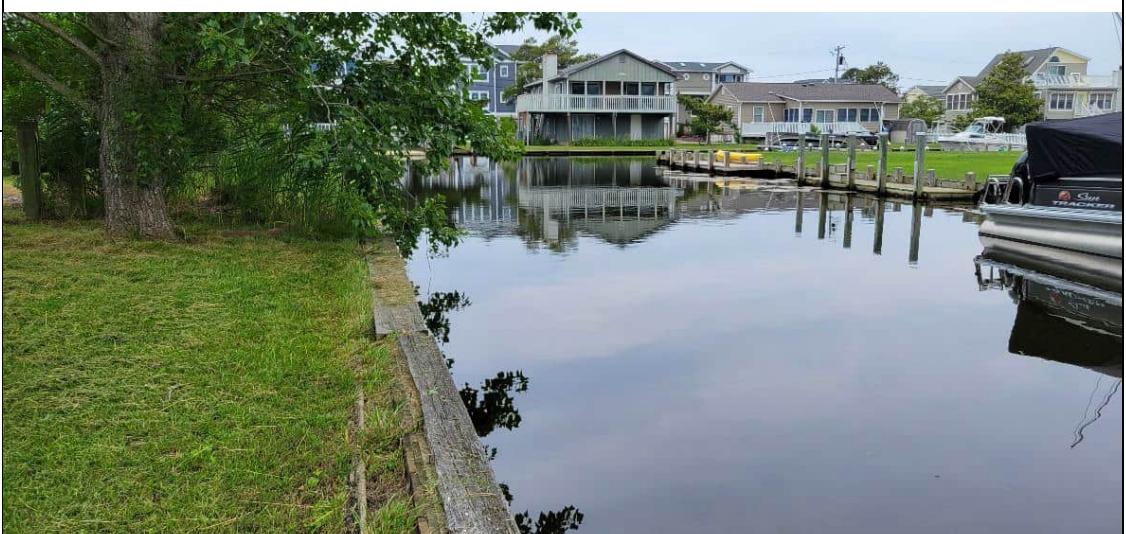
<b>Photo No.</b> 6	<b>Date:</b> 6/5/2024	
<b>Direction Photo Taken:</b>  Northwest		
<b>Description:</b>  View of Wetland 5 (W5 EUB), an estuarine unconsolidated bottom feature. This is a reinforced canal used for recreational boating and is named Boone Canal.
