# Town of South Bethany York Road Flood Mitigation & Design Study

June 23, 2025

# 1 INTRODUCTION

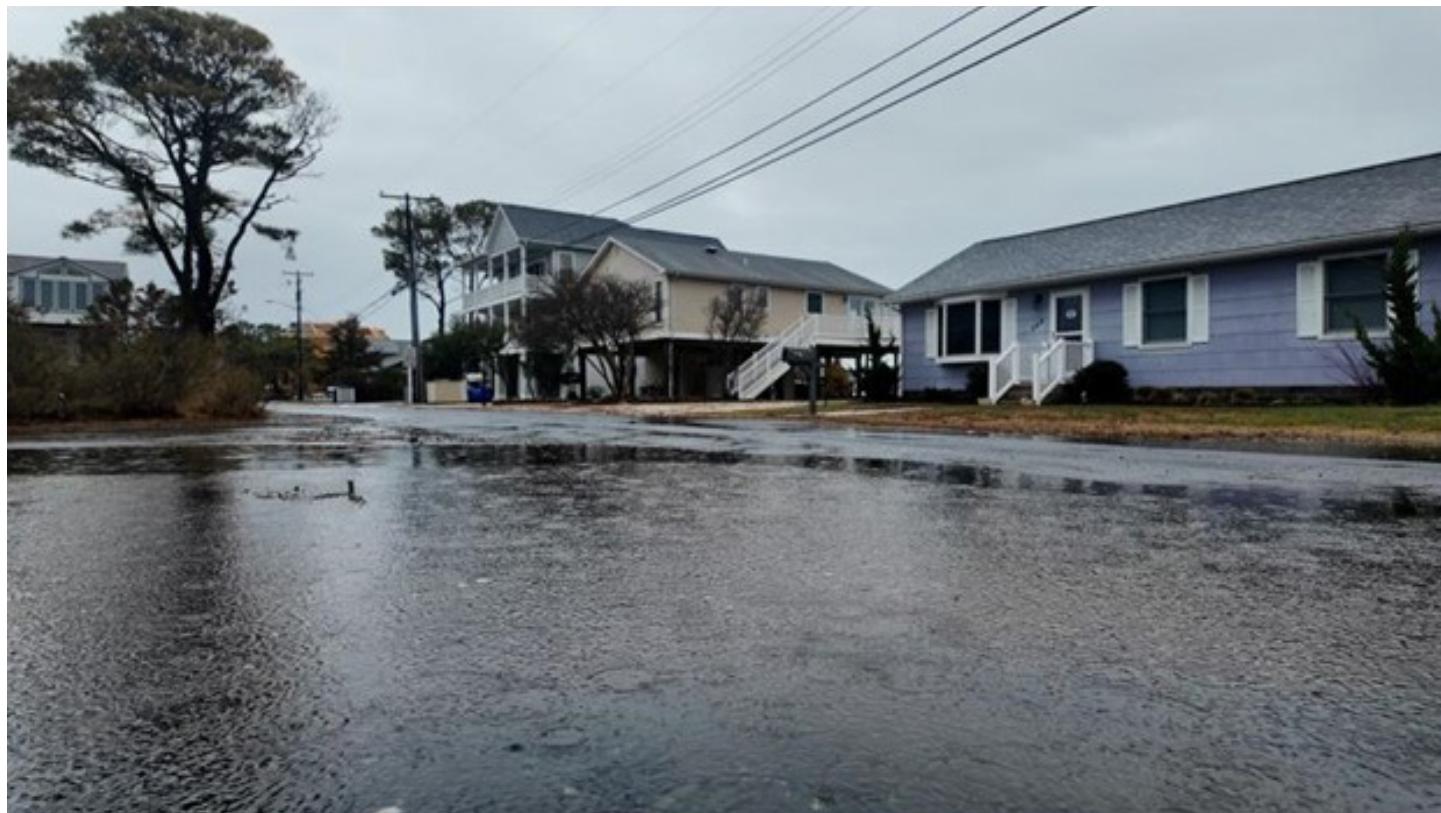
*Figure 1.1. A flooded portion of York Road.*

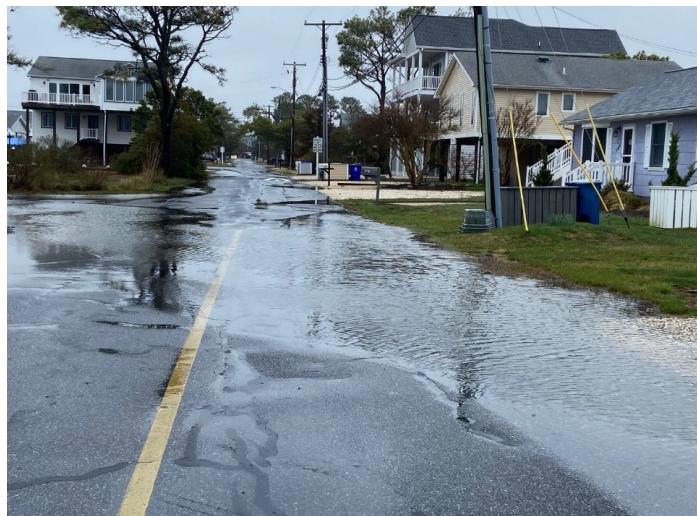
*Figure 2.1. Inundation of York Road just south of the intersection with Plymouth Road during a typical rainfall.*

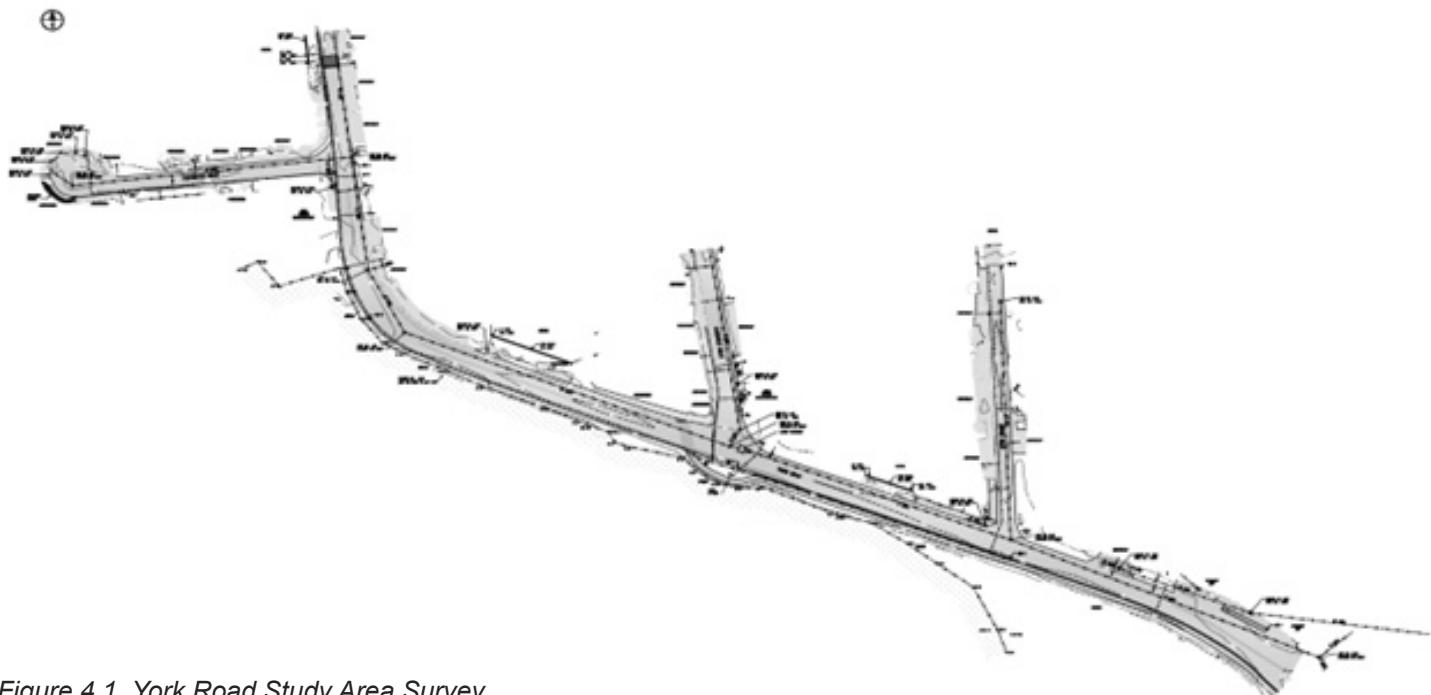
Figure 4.1. York Road Study Area Survey

York Road currently has an average elevation of 1.70' NAVD88 as determined by the road survey that was completed by the AECOM project team and is shown as Figure 4.1 below. The average elevation of York Road is relatively low and therefore exacerbates the flooding issues that plague the roadway.

The number of days when the water level exceeds the elevation of York Road is increasing annually. Paired with a low roadway elevation, York Road faces significant flooding issues.

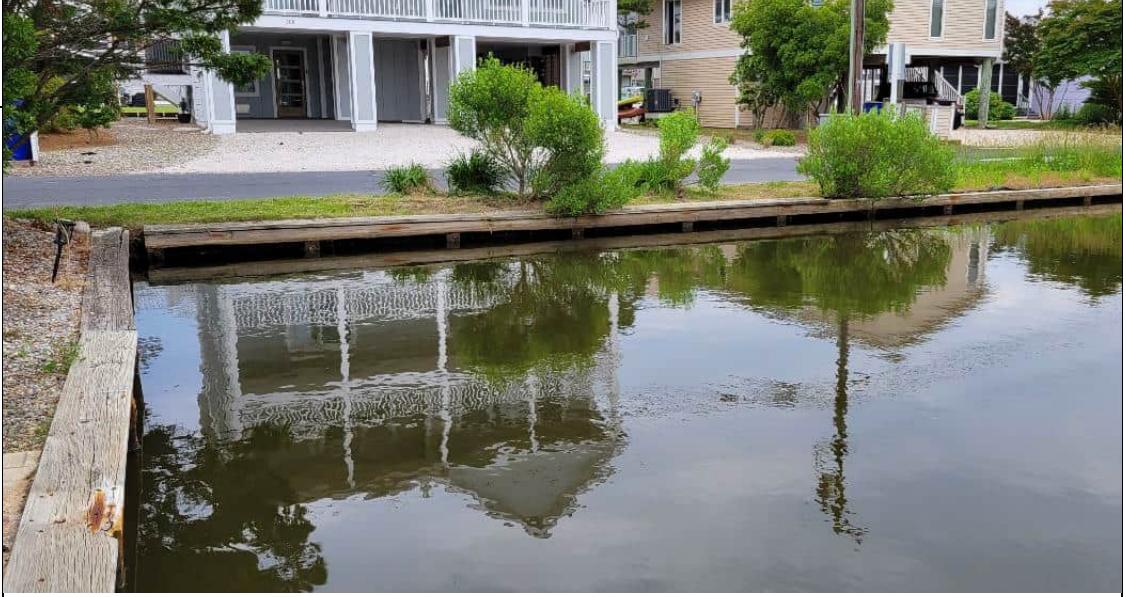
<b>Description:</b>  View of Wetland 2 (W2 EUB), an estuarine unconsolidated bottom feature. This is a reinforced canal used for recreational boating and is named Bristol Canal.

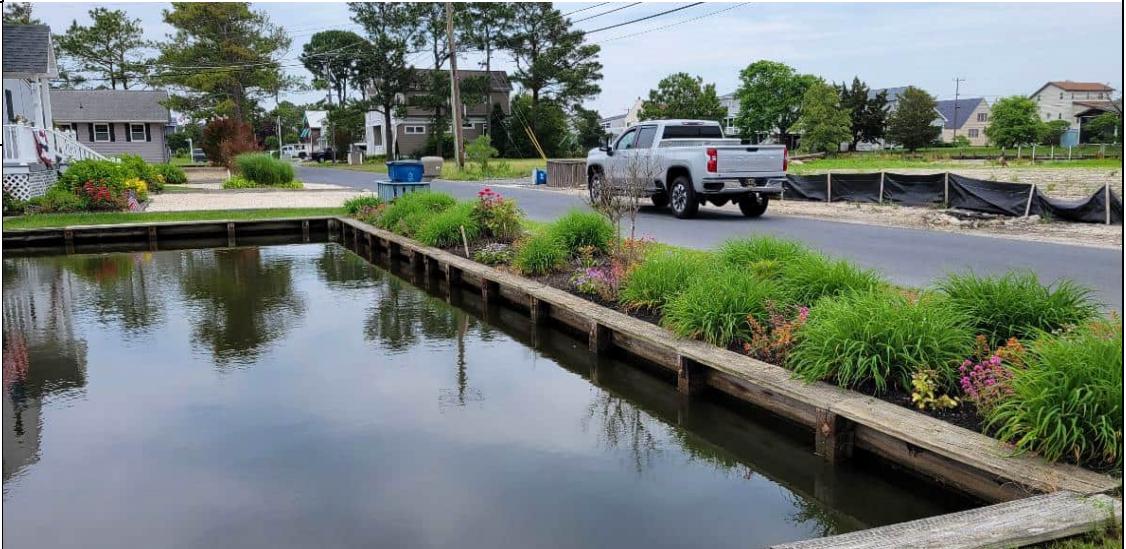
<b>Photo No.</b> 4	<b>Date:</b> 6/5/2024	
<b>Direction Photo Taken:</b> East

<b>Description:</b>  View of Wetland 3 (W3 EUB), an estuarine unconsolidated bottom feature. This is a reinforced canal used for recreational boating and is named York Canal.

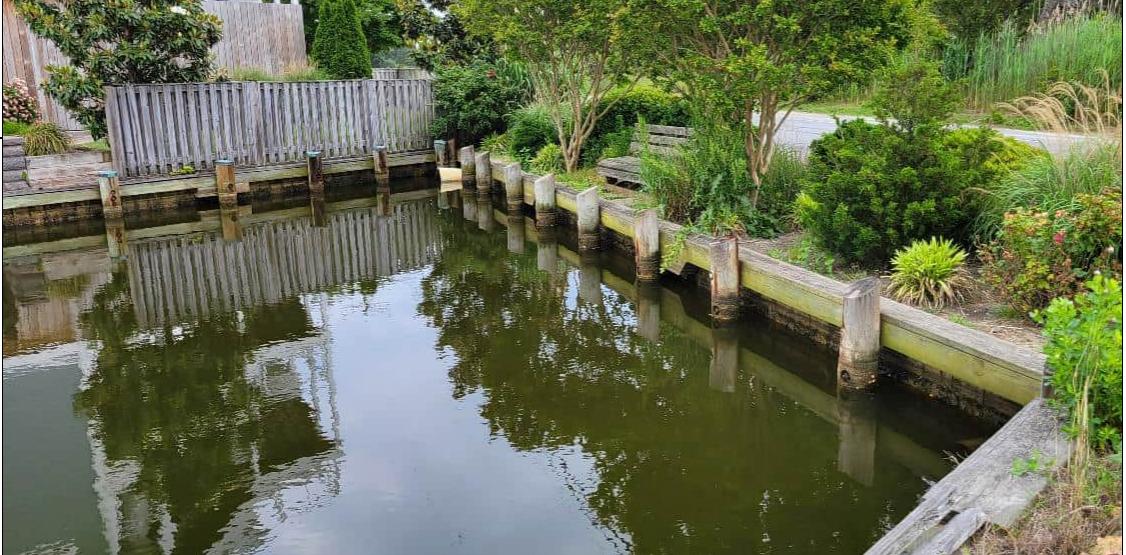
<b>Description:</b>			
View of Wetland 4 (W4 EUB), an estuarine unconsolidated bottom feature. This is a reinforced canal used for recreational boating and is named Carlisle Canal.

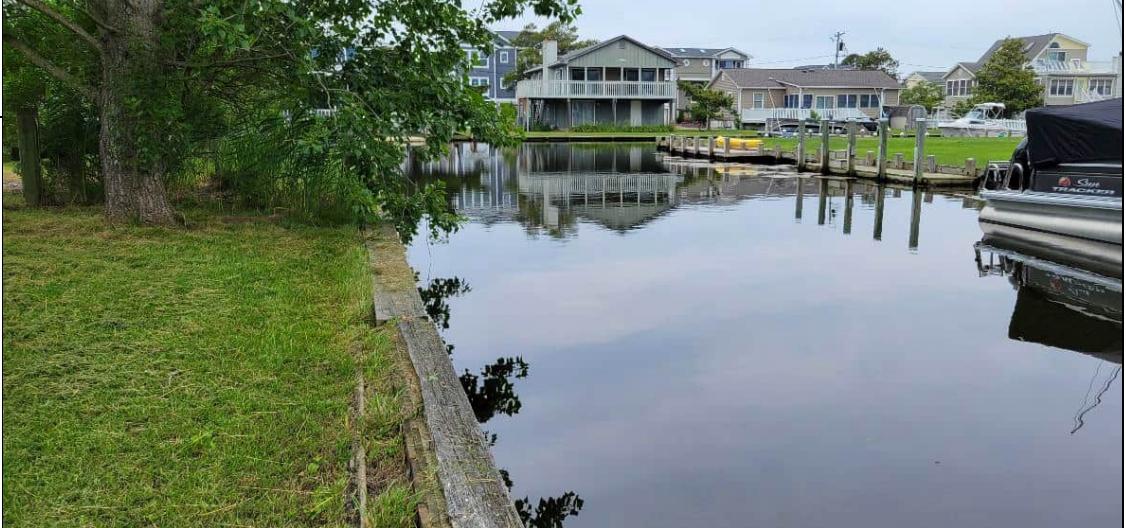
<b>Photo No.</b> 6	<b>Date:</b> 6/5/2024	
<b>Direction Photo Taken:</b>		
Northwest

<b>Description:</b>		
View of Wetland 5 (W5 EUB), an estuarine unconsolidated bottom feature. This is a reinforced canal used for recreational boating and is named Boone Canal.

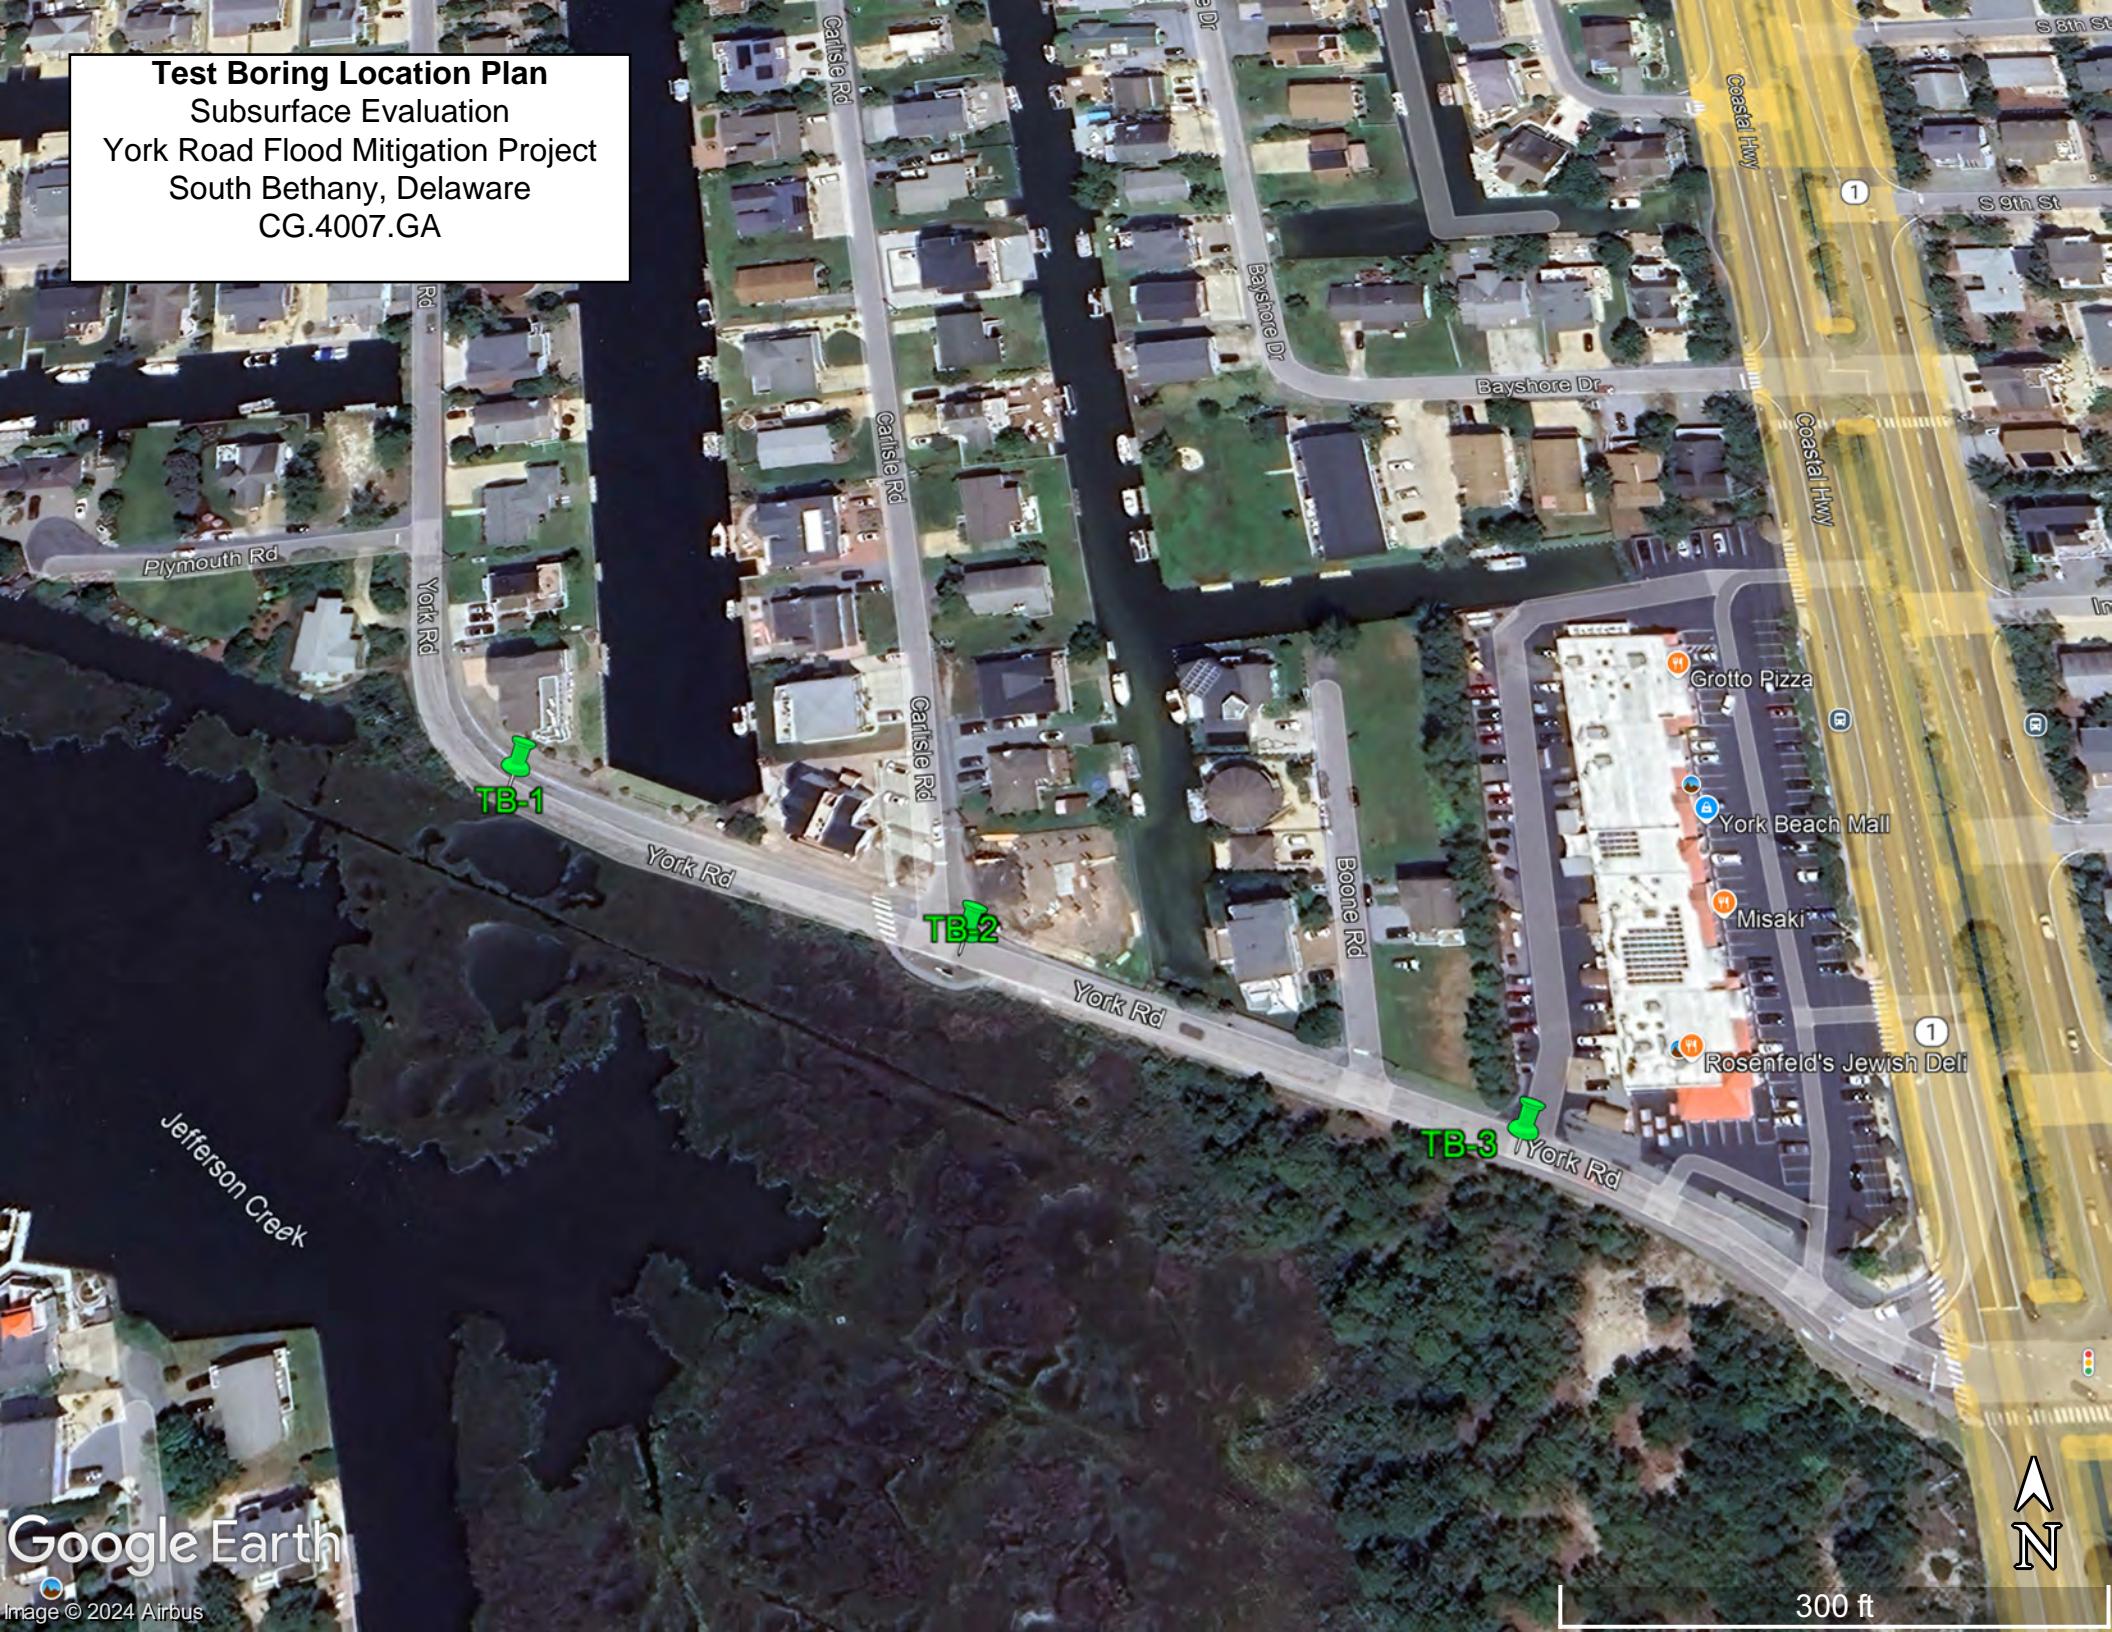
# TEST BORING TB-1

Subsurface Evaluation York Road Flood Study South Bethany, Delaware CG.4007.GA				Date Started : August 27, 2024 Date Completed : August 27, 2024 Logged by : M. Natrin Weather : Sunny, 80s Driller/Agency : J. Truver/CGC Geoservices								Drilling Equipment: CME 75 Truck Drilling Methods : HSA,SPT									
Depth in feet	Layer Depth feet	GRAPHIC	USCS	Sample Condition		Water Levels		SAMPLES	Sample Number	Blows per 6 inches	Recovery (ft)	Moisture Content (%)	Percent Passing 200 Sieve	WATER LEVEL							
				Remolded	During Drilling	▼	▼														
DESCRIPTION																					
0				Bituminous concrete pavement (8 inches)

0.7				Moist, gray fine to medium SAND, little silt, trace clay																	
2				Wet, gray fine to medium SAND, little silt, little clay																	
4				Wet, gray fine to coarse SAND, little silt, trace clay																	
6		SM		Wet, gray fine SAND, trace silt																	
8				Wet, brown/ gray fine SAND, some silt, some organics with wood fibers (peat)																	
10				Wet, gray fine SAND, trace silt, trace clay

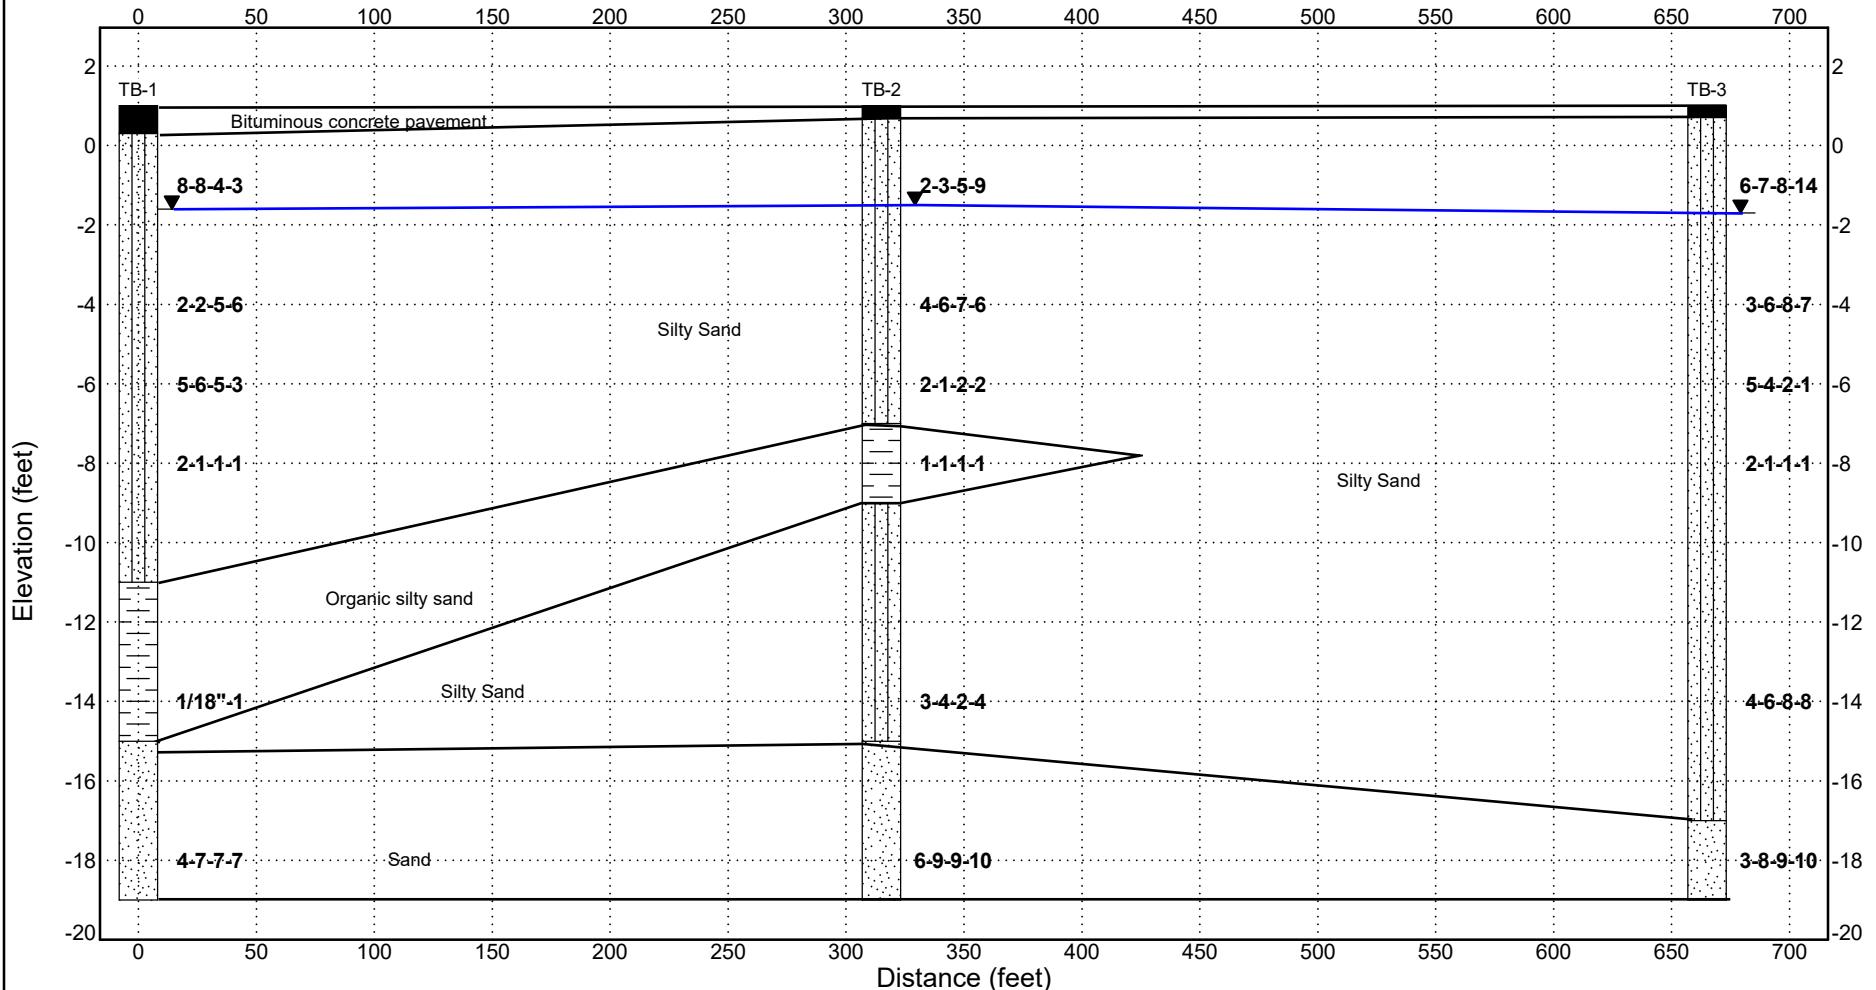
## STRATIGRAPHIC PROFILE

The subsurface conditions encountered consisted of a surface layer of bituminous concrete pavement varying in thickness from 4 to 8 inches, overlying predominately granular soils of loose to medium density. In borings TB-1 and TB-2, a layer of very loose / soft organic material was observed within the granular soils at depths varying from 8 to 12 feet below grade. The organic layer was not observed in boring TB-3, located furthest east along the road section.

A stratigraphic profile depicting the conditions observed is enclosed. The profile interpolates the conditions between the boring locations, however actual stratigraphy may vary.
